EXTERIOR REHABILITATION

MONTHLY CONSTRUCTION PROGRESS REPORT

August 2015

15039DB – Oklahoma Capitol Restoration/Exterior Rehabilitation

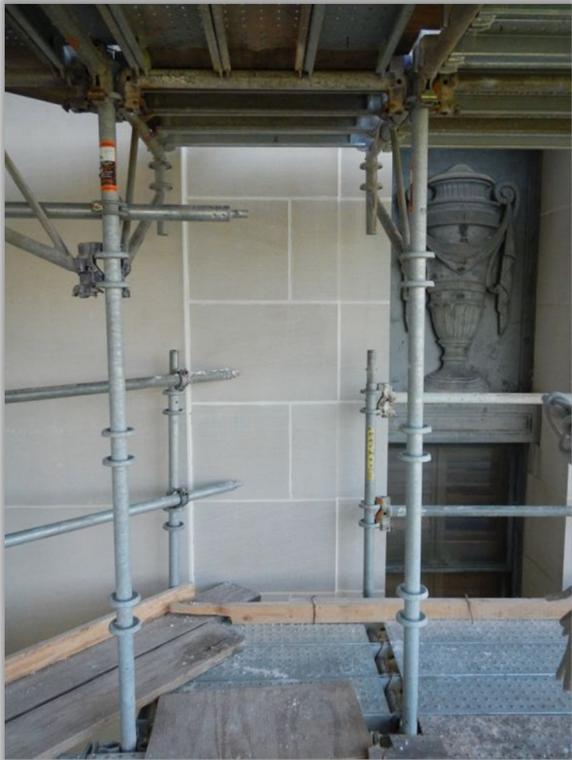
The repointing portion of the mortar joint trials has been completed. Discussions with masons regarding means, methods, and realistic outcomes from this portion of the work have taken place and are completed.

**Completed
Repointing Trial**

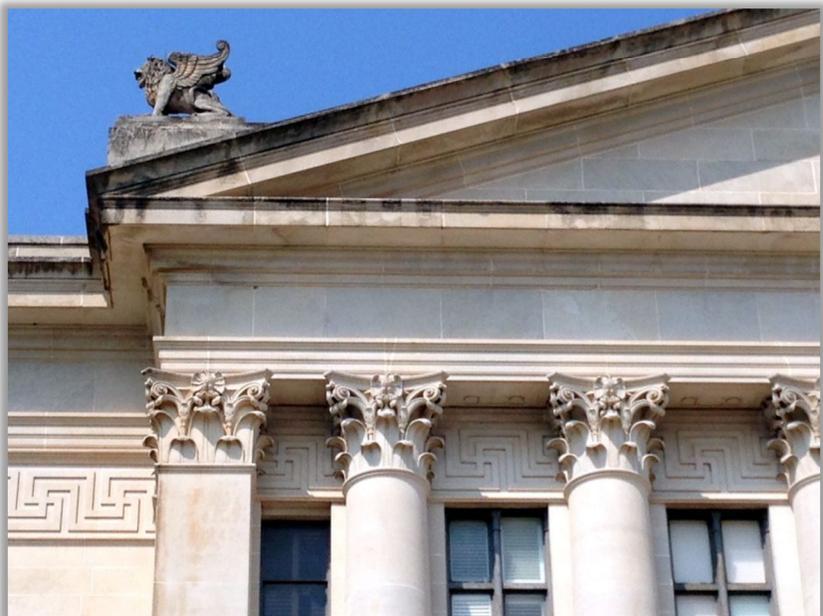
Treanor Architects completed masonry cleaning trials which included laser cleaning of limestone and granite to remove orange/brown staining, biological cleaning trials of limestone, heated water washing of limestone to remove orange/brown staining, and rust removal trials.

**Biologic Agent
Cleaning Trial**

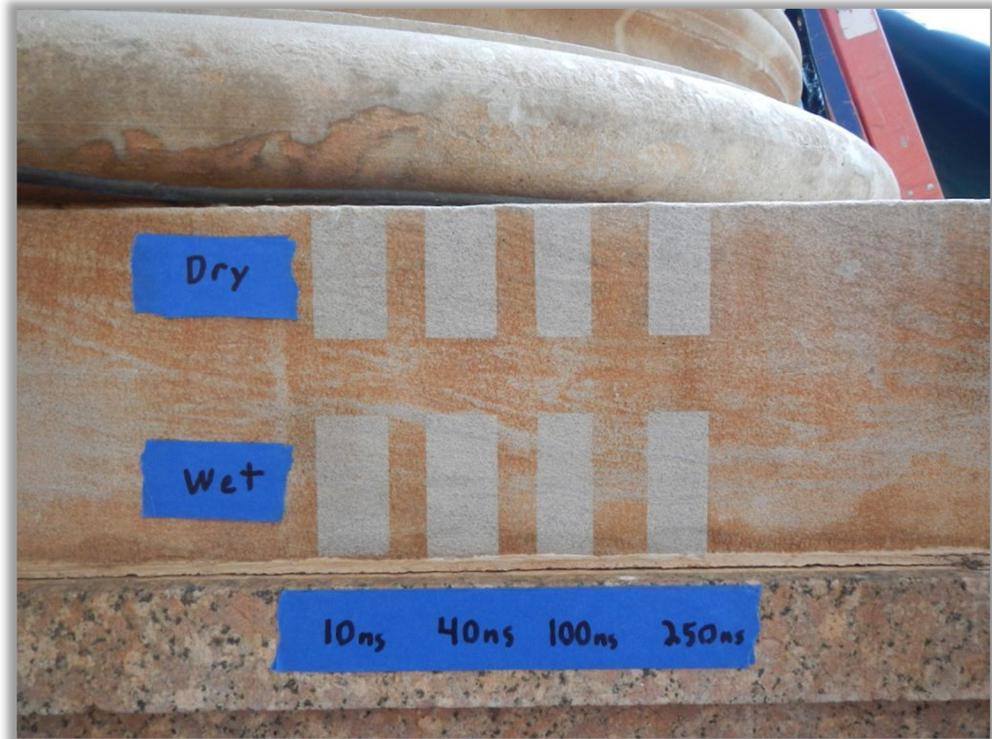
Laser Cleaning Trial

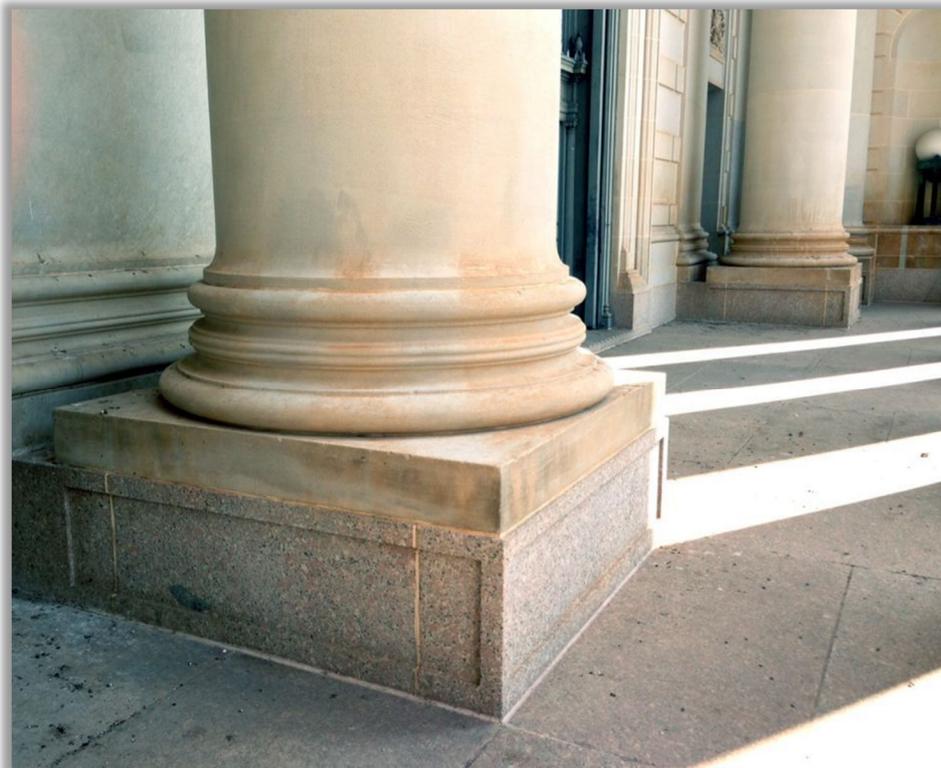
Hot Water Wash Cleaning Trial

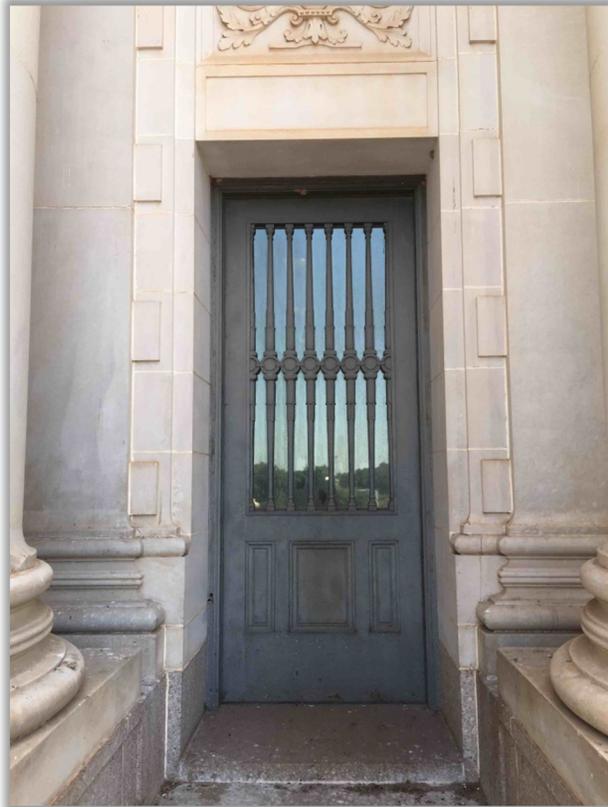
Door 201

Treanor accessed and observed monumental hollow metal door 201 at the South Portico and developed a draft document for pricing door restoration option.

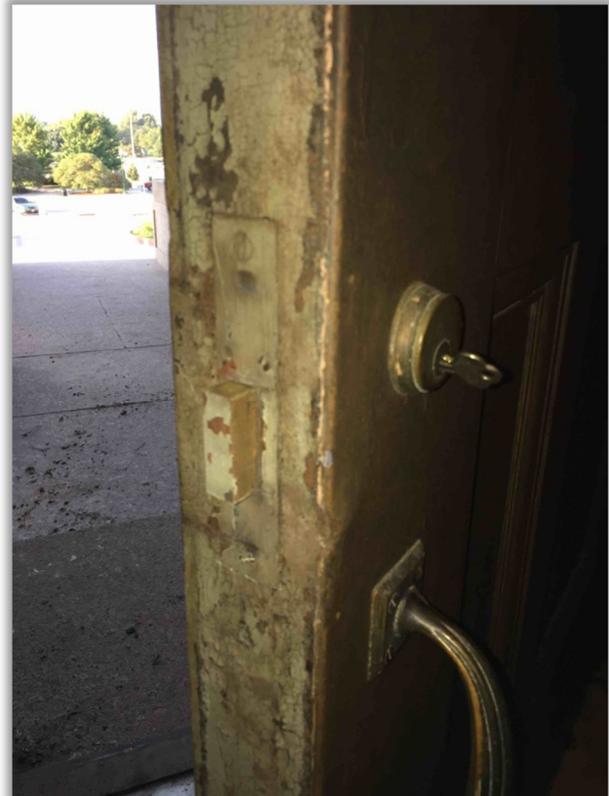
**Door 201 Mortise
Lock Condition**

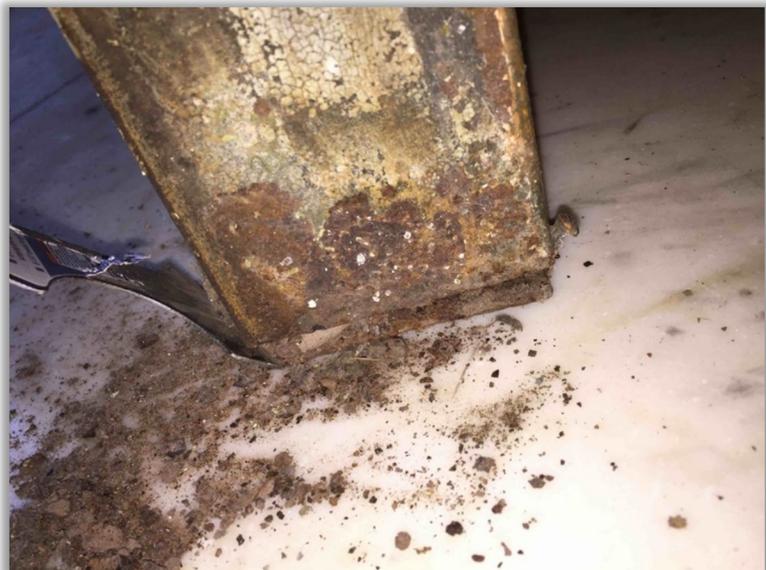
**Door 201 Sill
Condition**
