OKLAHOMA STATE CAPITOL RESTORATION  
*Exterior Rehabilitation*

SEPTEMBER 2016

15039DB MONTHLY CONSTRUCTION PROGRESS REPORT

## ENGINEER'S FIELD REPORT

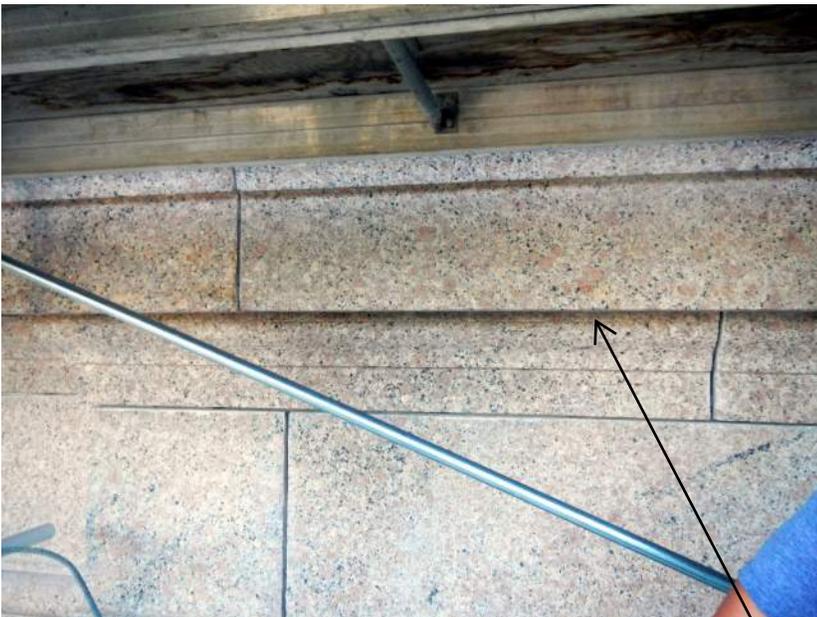
Partial view of raked area granite area

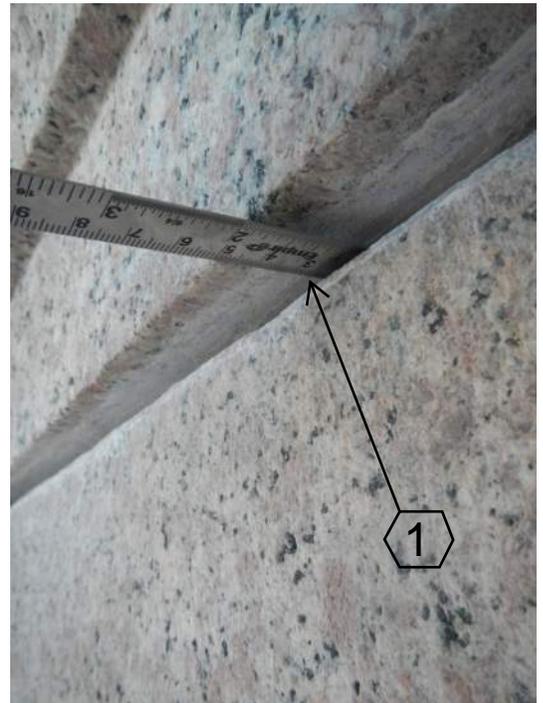
Verify raking has reached 1" minimum depth specified

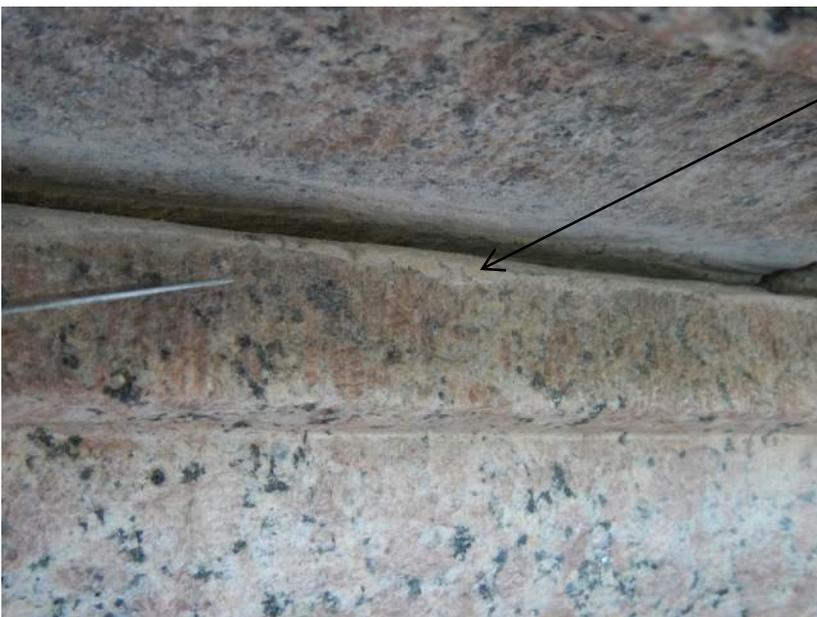
Bed joint under the water table is challenging to reach due to geometry of overhanging stone - verify previous mortar has been removed entirely. Small area was not complete upon review

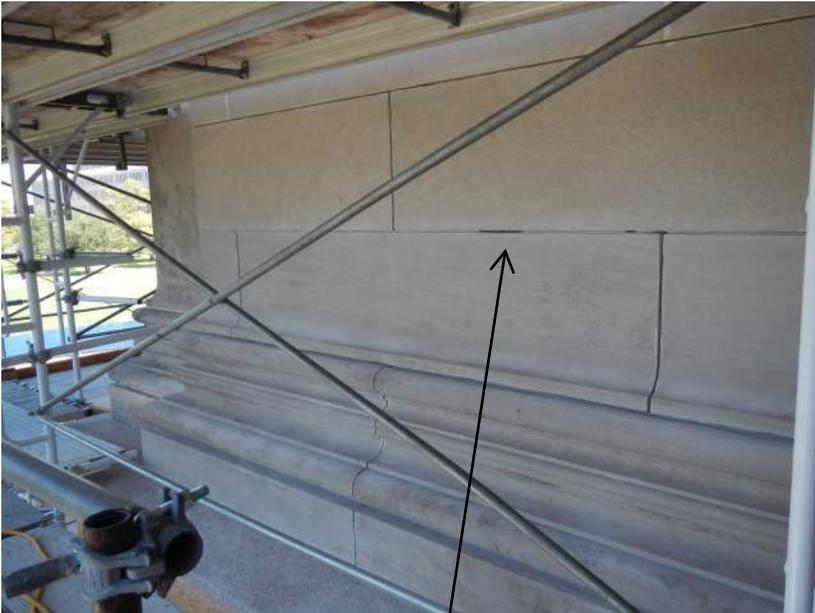
Partial overview of raked area of limestone. Head joints in limestone ashlar were open in this location.

— small void found in bed joint

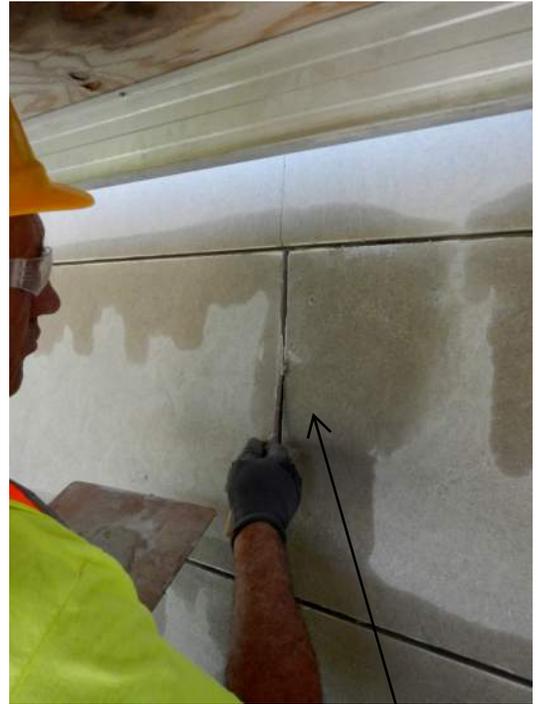
2

Placing initial setting mortar to fill an open head joint in limestone with setting mortar per A2/A403.

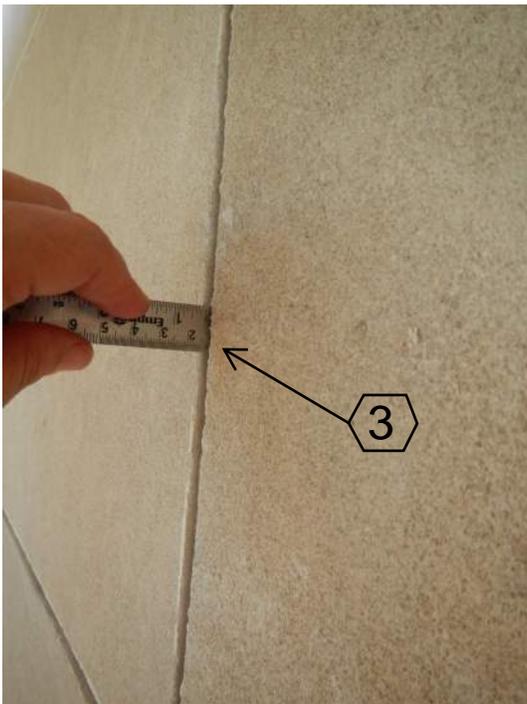
3

Verifying depth of initial pointing (setting mortar used for initial pointing).

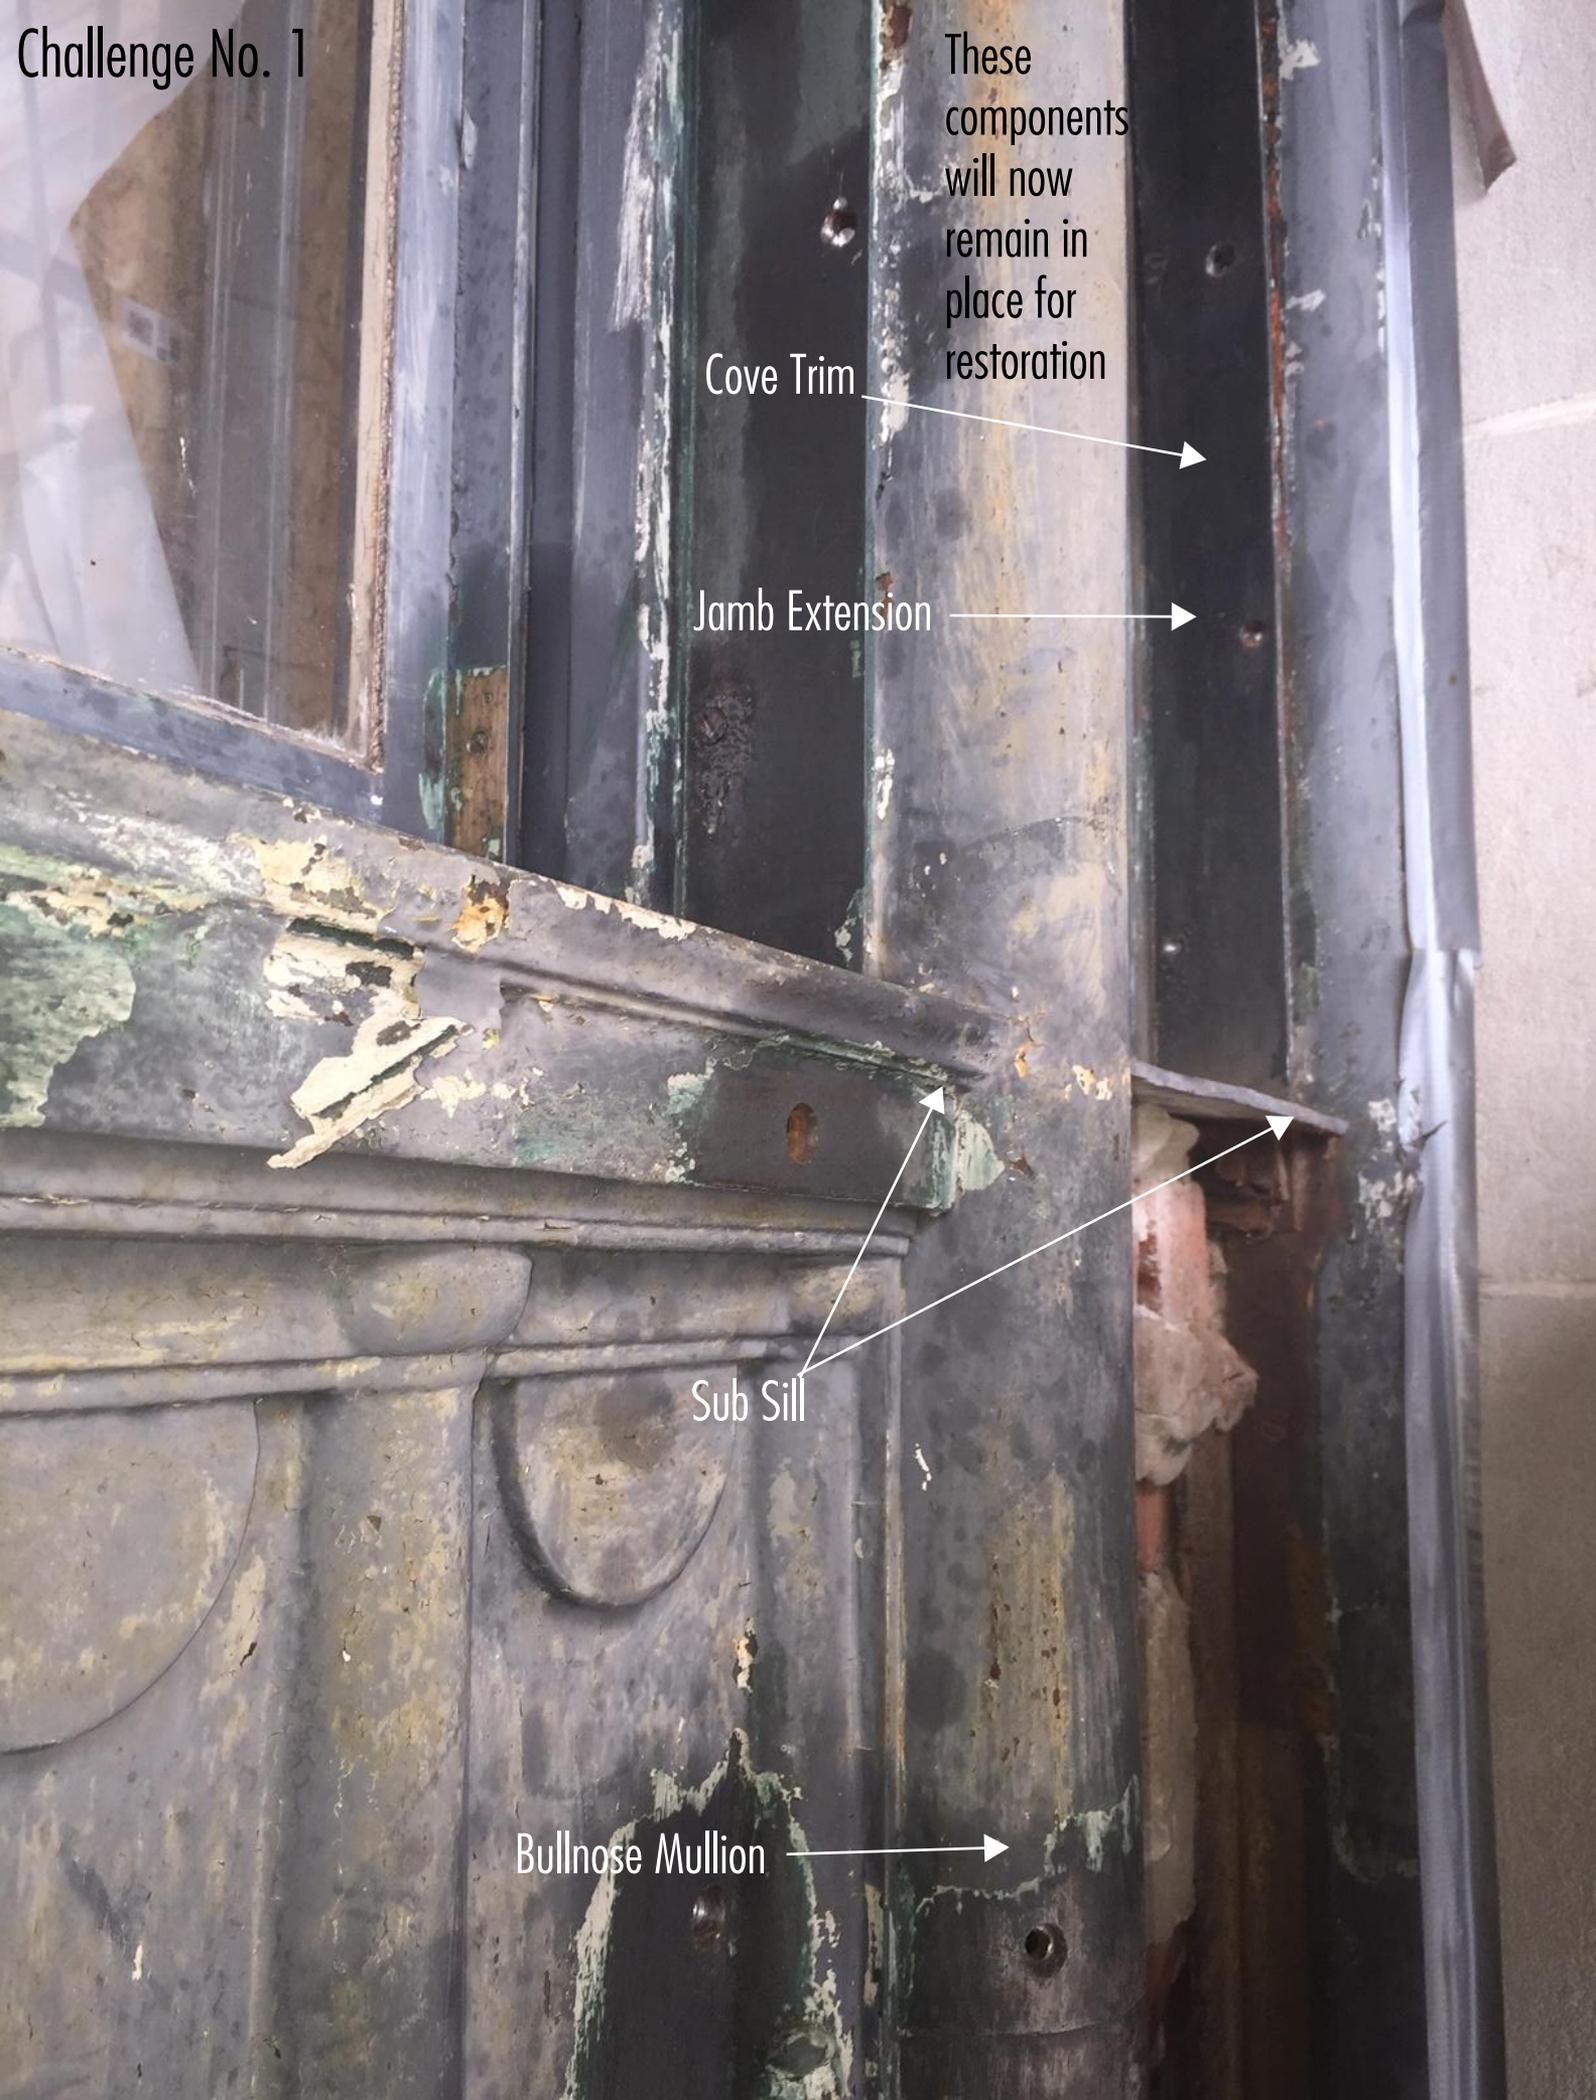
**1** Type G Window Challenge: Hidden fasteners behind the building skin have prevented our team from being able to disassemble the windows as we had originally planned. Thus far, all windows were intended to disassemble to an extent that would allow us to restore varying pieces for restoration off-site. The discovery of this condition changed how we would proceed with restoring these type of windows. The subsequent photos show the hidden fasteners and describe how we will accomplish restoring these windows without having to physically remove them as originally planned.

These components will now remain in place for restoration

Cove Trim

Jamb Extension

Sub Sill

Bullnose Mullion

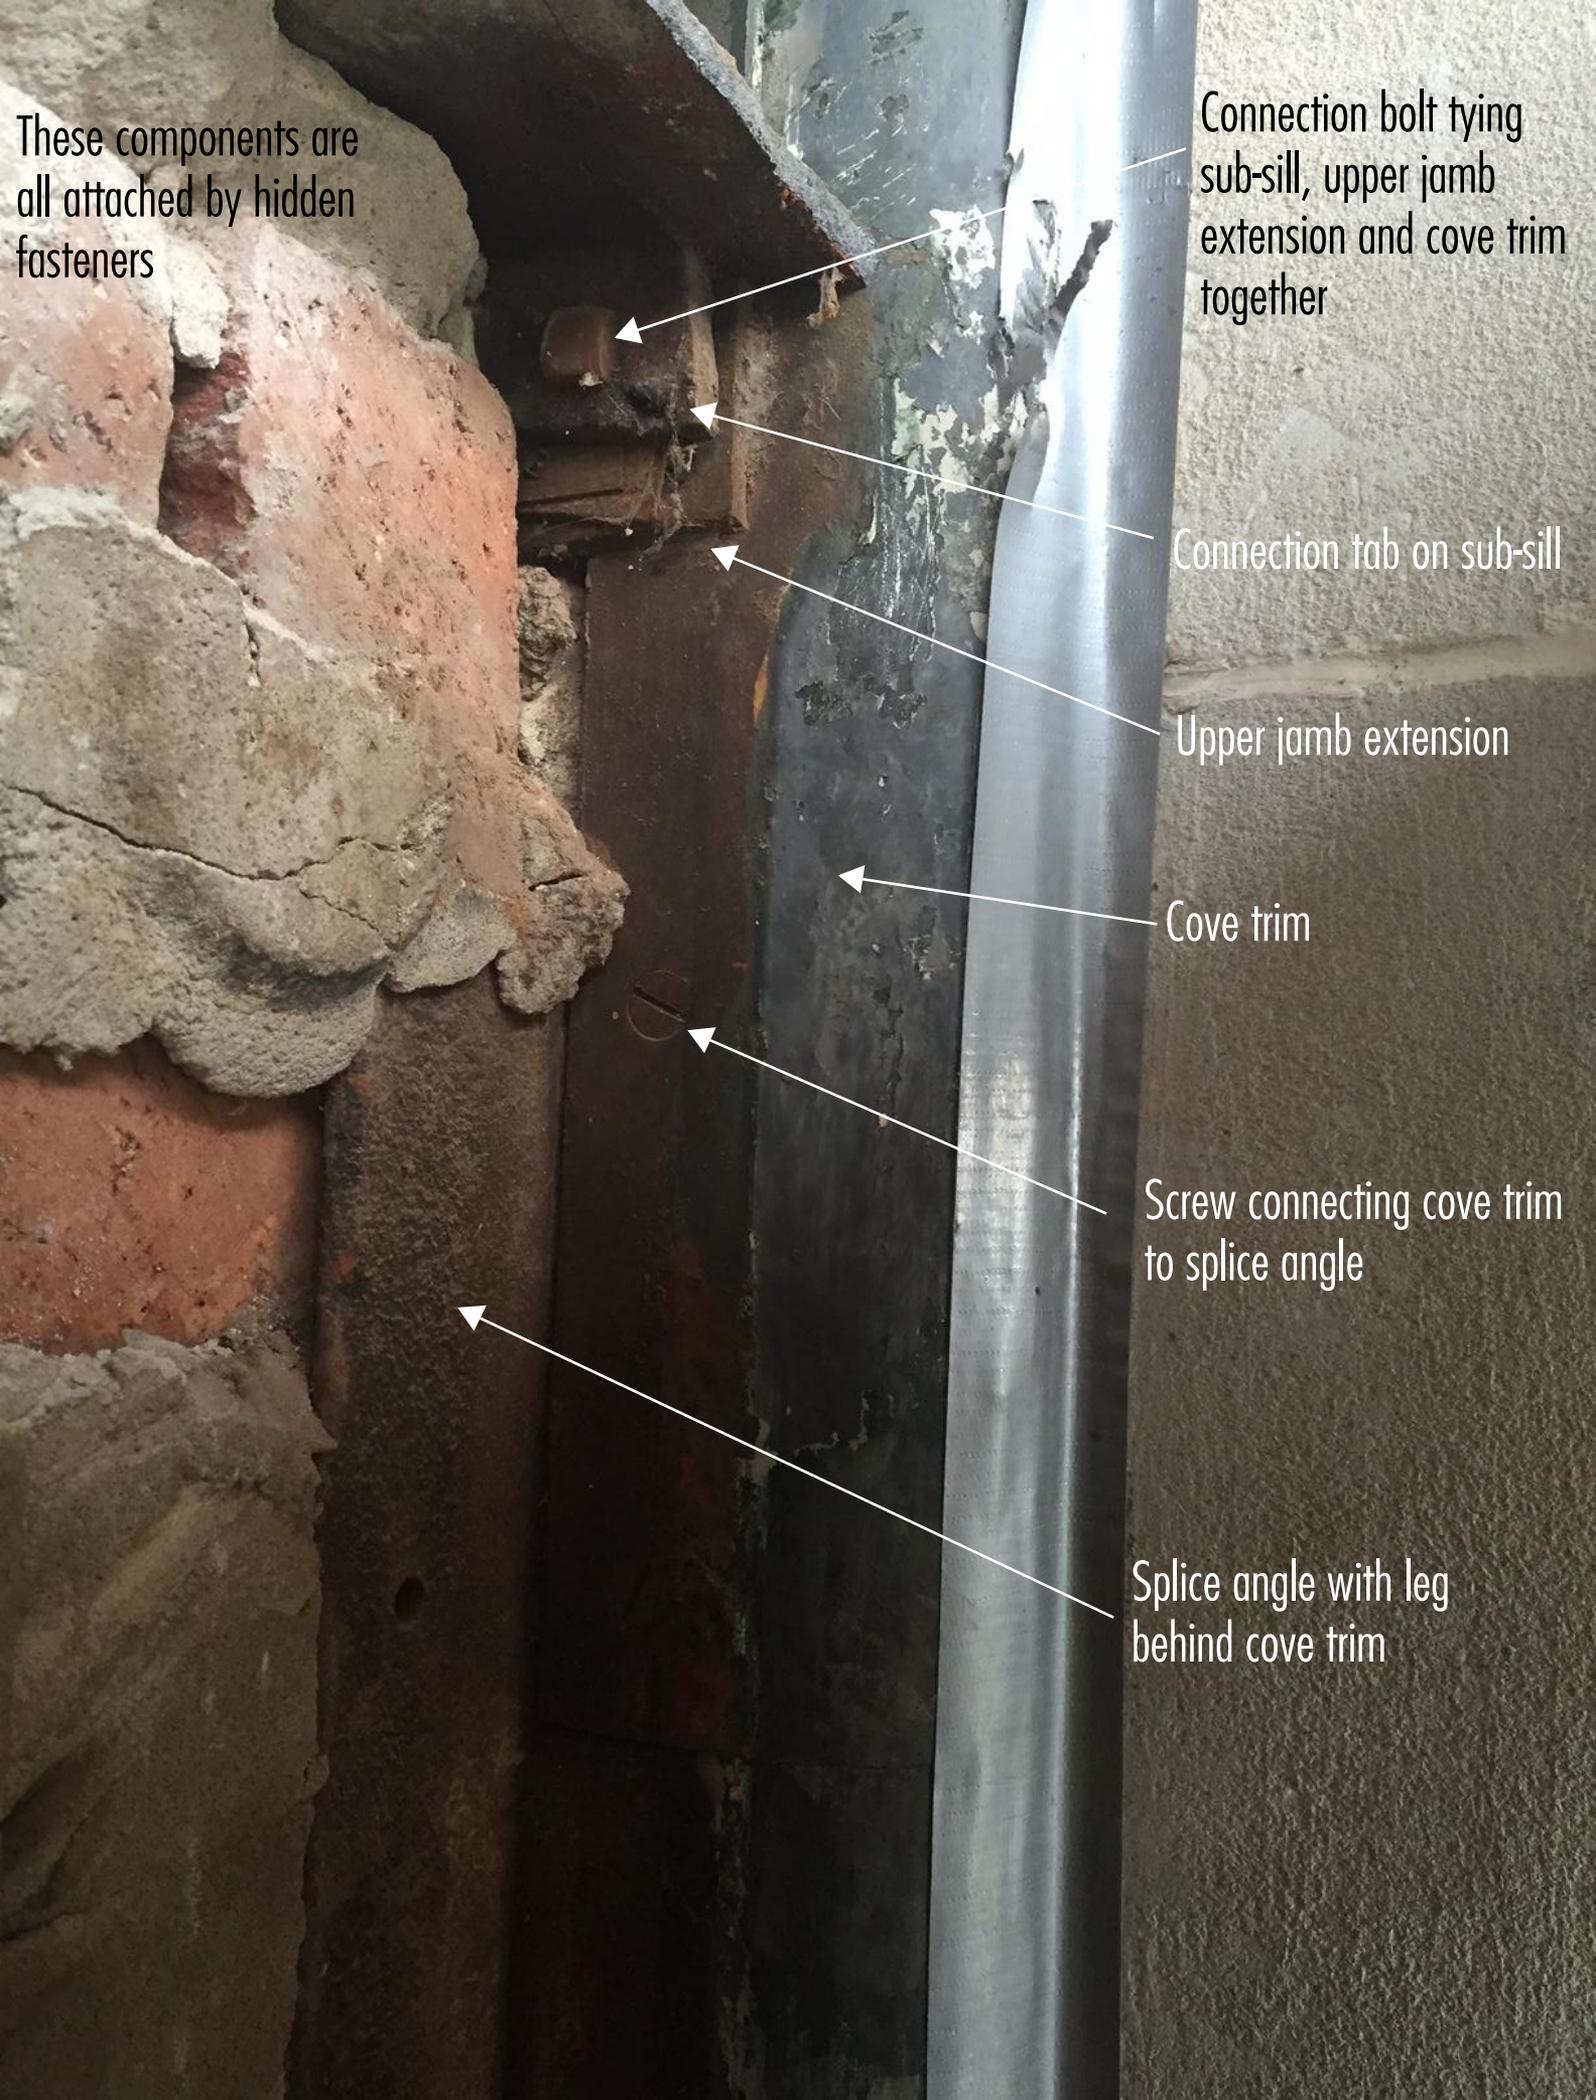
These components are all attached by hidden fasteners

Connection bolt tying sub-sill, upper jamb extension and cove trim together

Connection tab on sub-sill

Upper jamb extension

Cove trim

Screw connecting cove trim to splice angle

Splice angle with leg behind cove trim

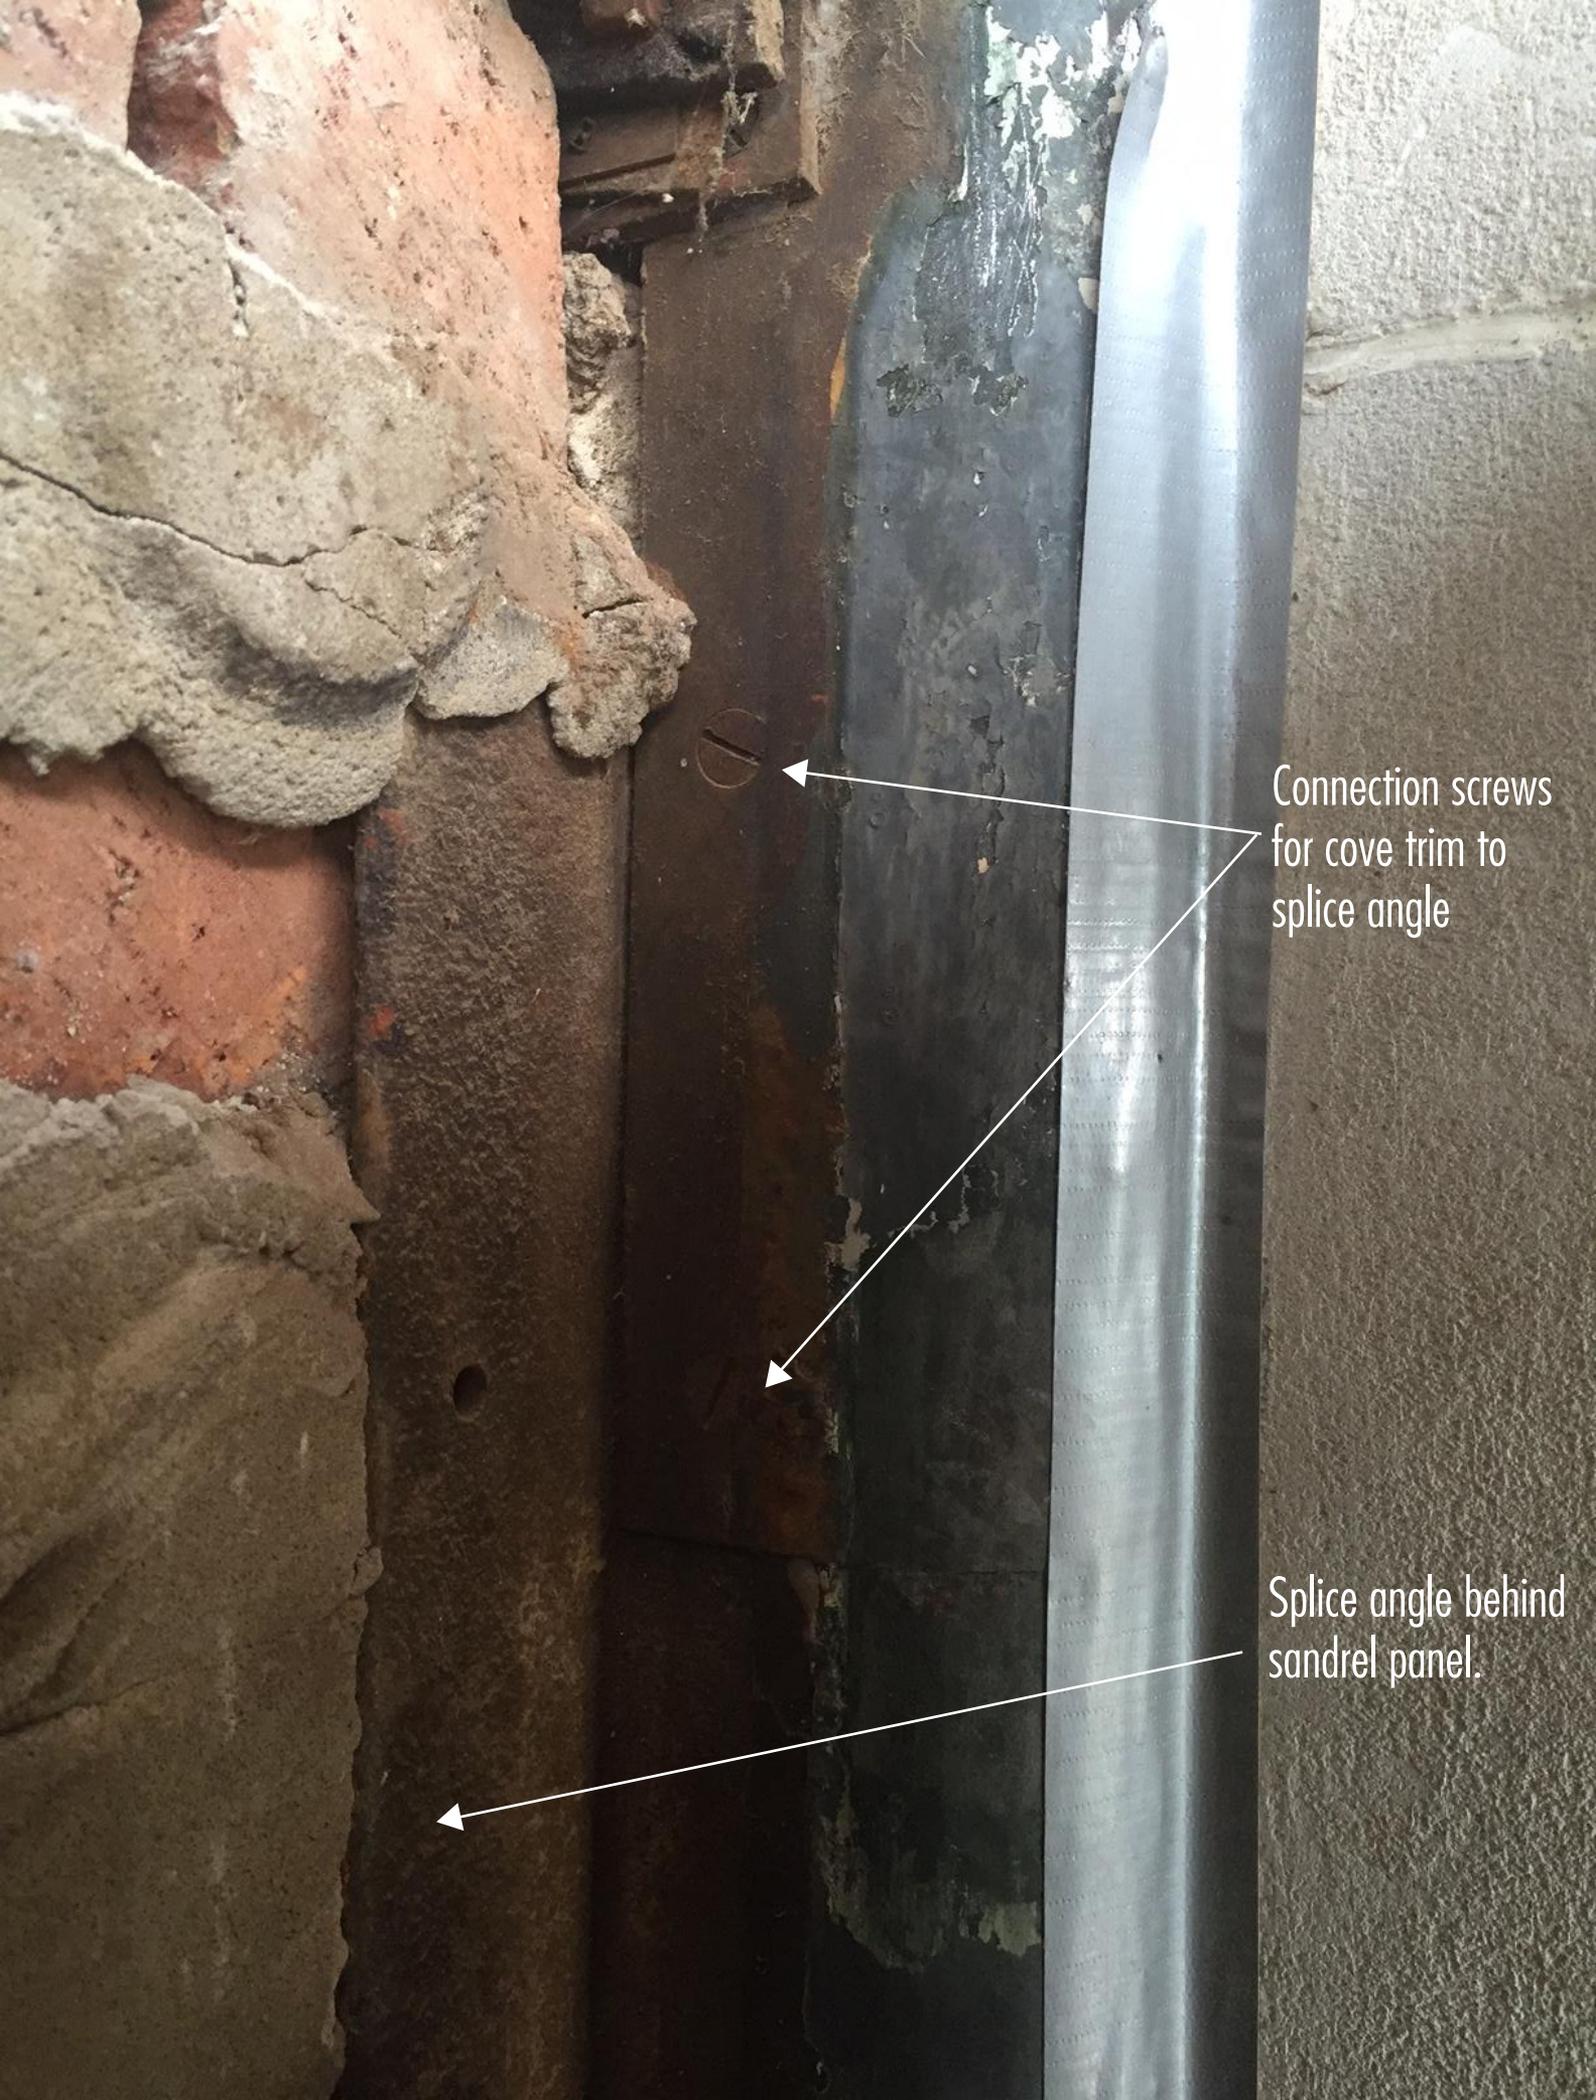
Connection screws  
for cove trim to  
splice angle

Splice angle behind  
sandrel panel.

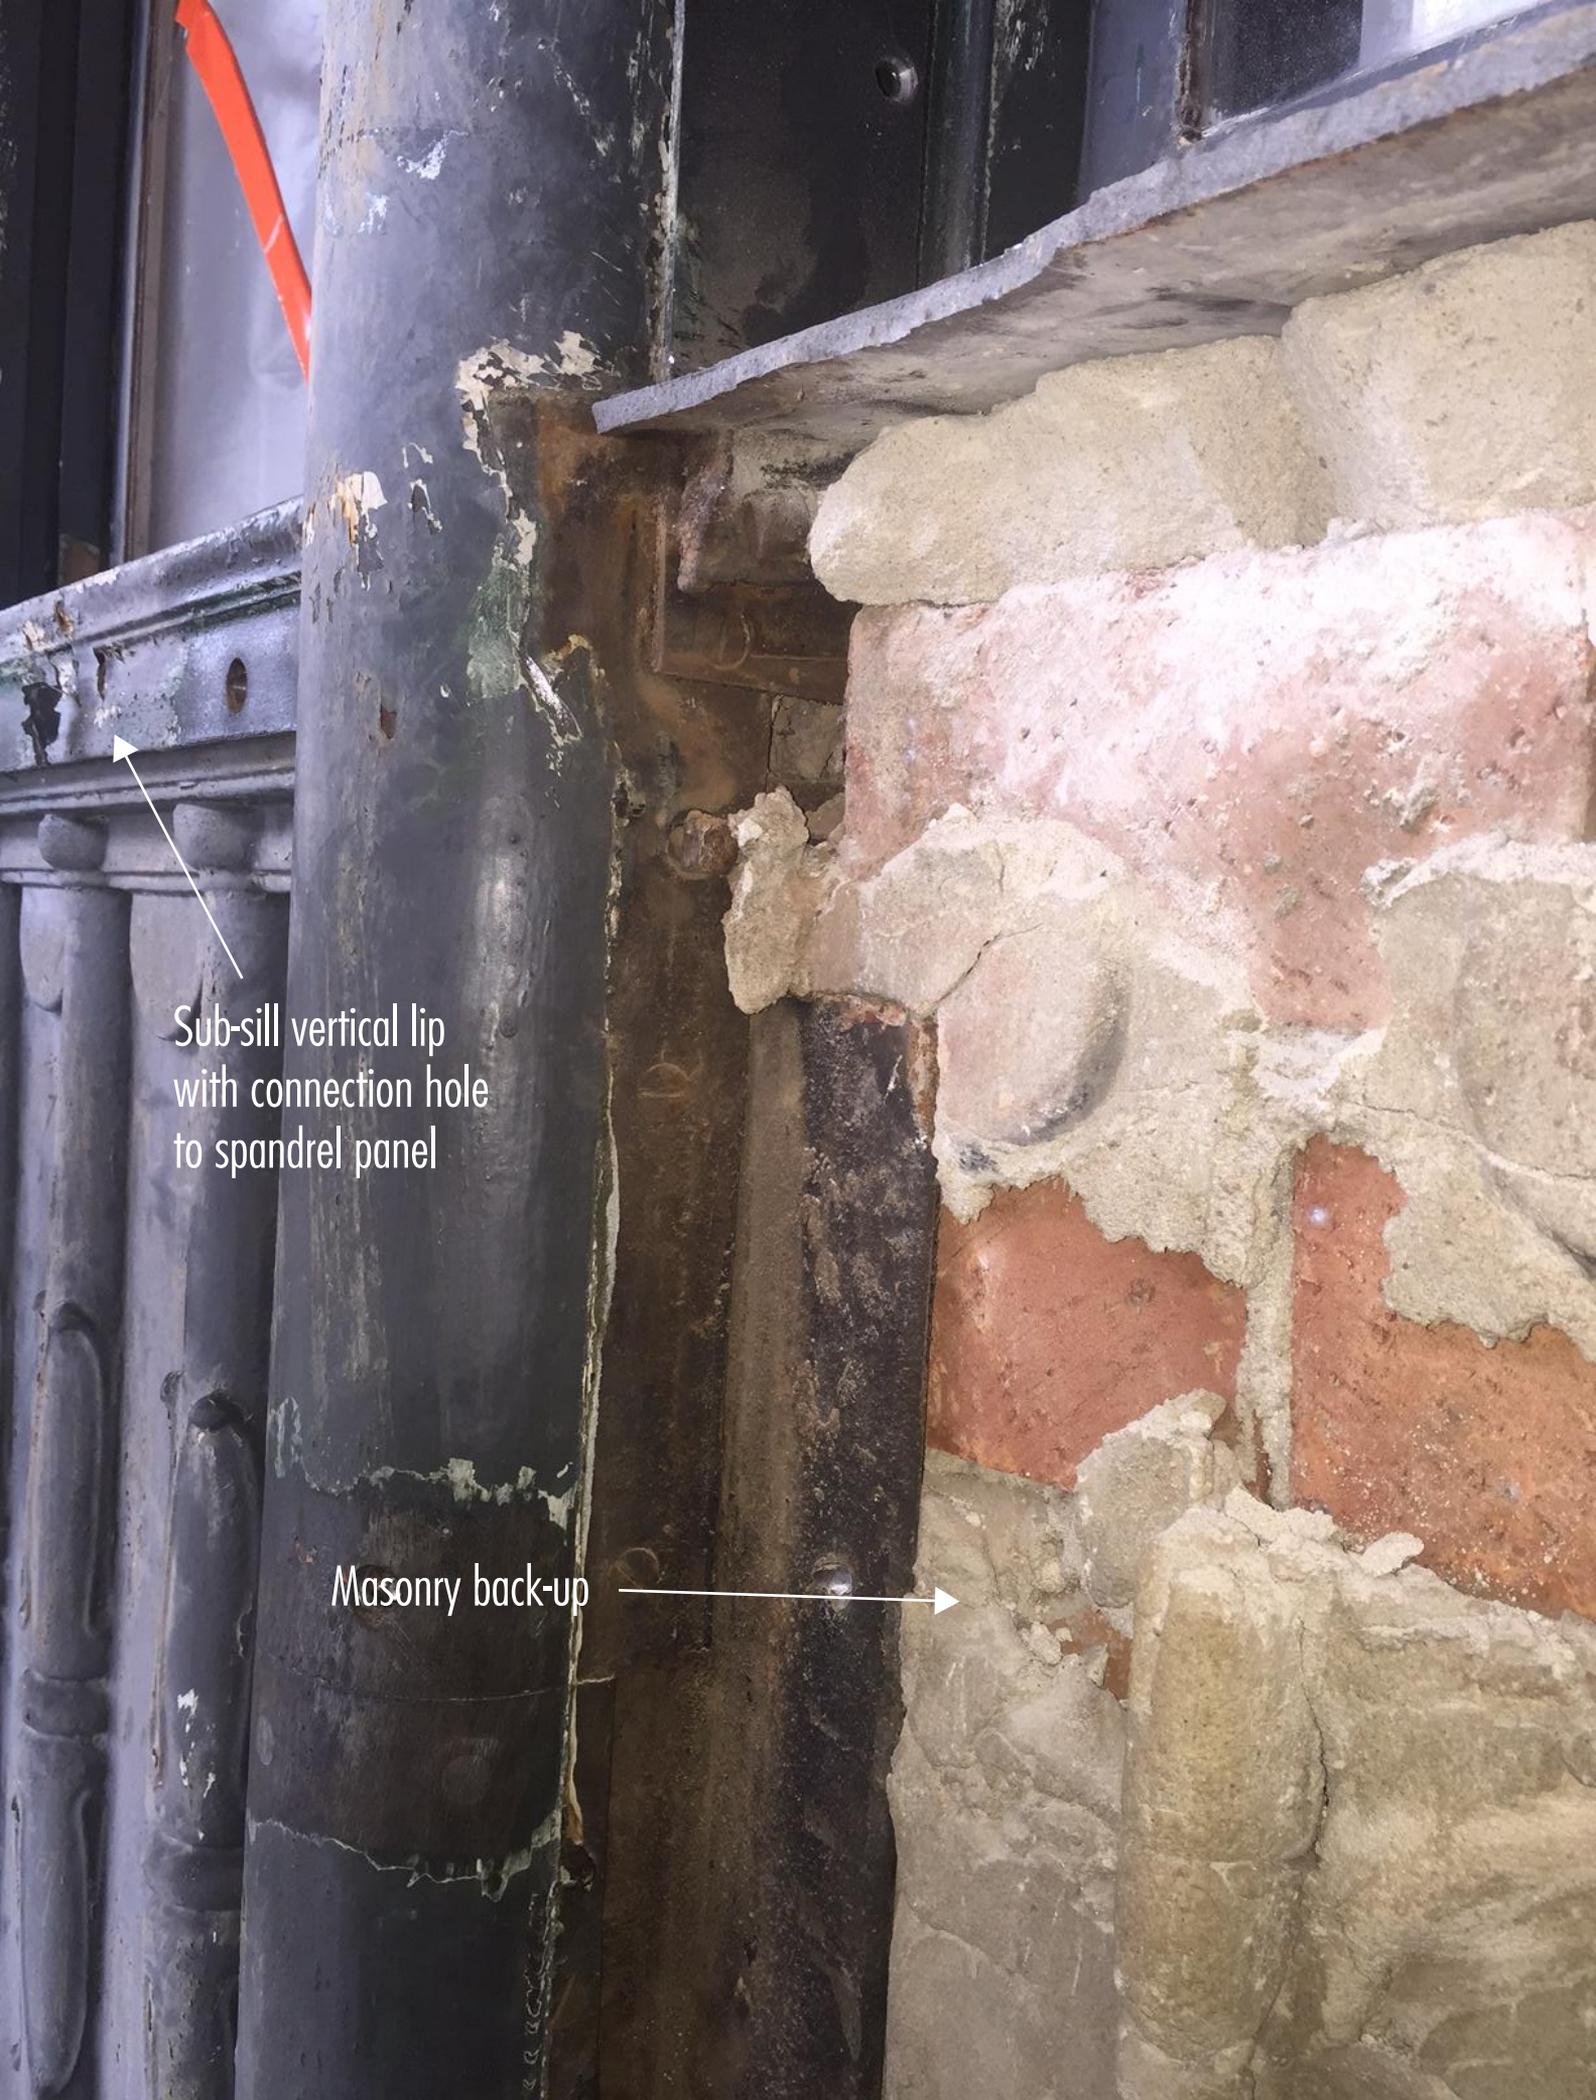
Sub-sill vertical lip  
with connection hole  
to spandrel panel

Masonry back-up

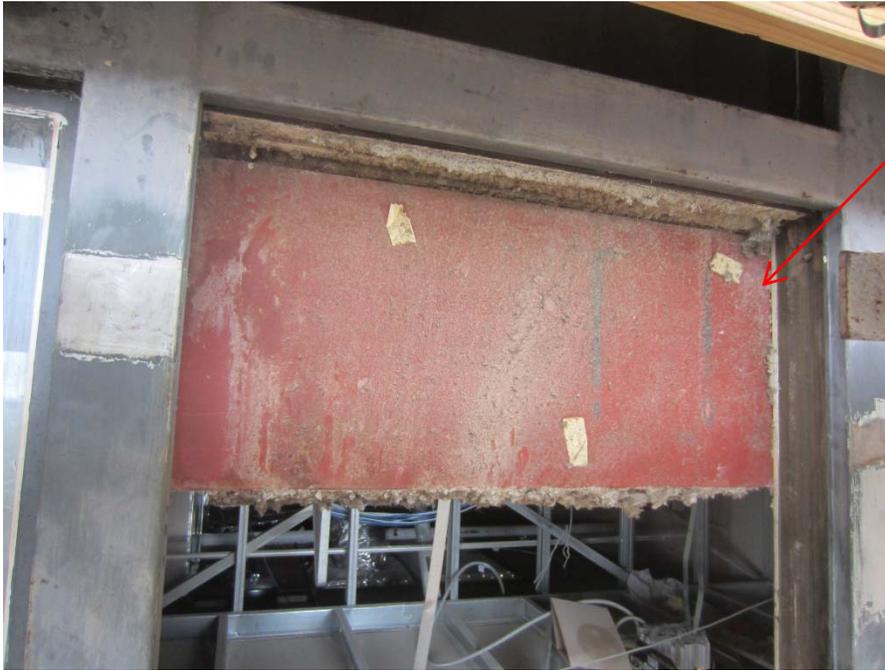
Photo 1 - 18 inch Channel Framing Across Window 264

1. After removing the temporary opening covers, ZFI personnel observed an 18 inch steel channel framing across the top portion of the window opening (See Photo 1 below).

prevents glass from  
being removed

After observing the framing and discussing the window conflict with Mr. Glenn, it was proposed that alternative window frame removal options be considered in lieu of attempting to modify the undocumented framing. It is our understanding that JE Dunn has begun to explore those options with the window designer and restoration subcontractor.

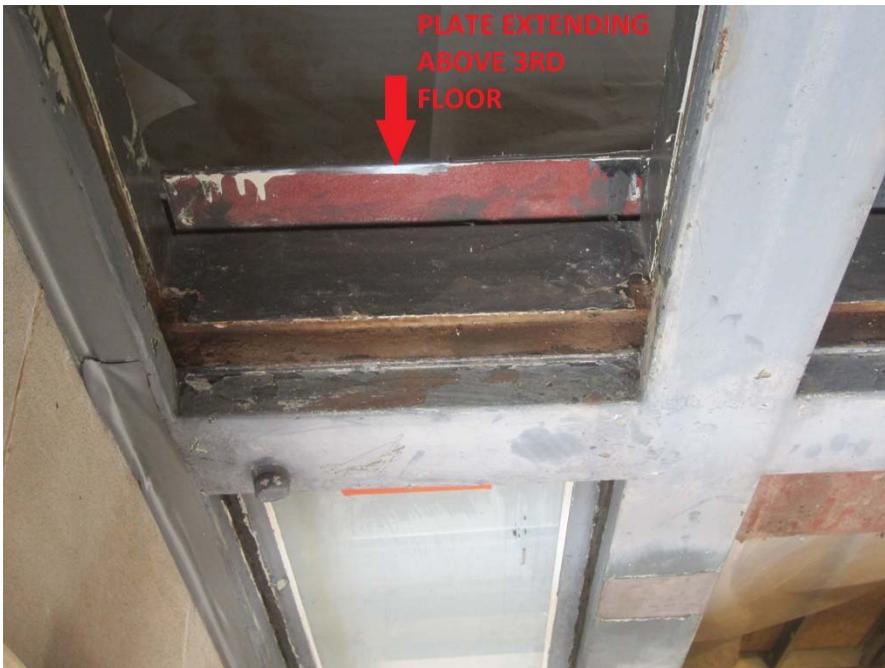
Photo 2 - Steel Plate Extending Above 3<sup>rd</sup> Floor

2. The channel is above the ceiling and the interior side was covered in spray-applied fireproofing. The channel was set flush against the window frame with the approximately 3 7/8 inch-wide flanges of the channel oriented toward the interior. The channel appeared to support a hot-rolled angle shape along its entire length (likely as a pour stop/deck support angle) and an additional vertical plate along the portion of its length in front of the windows (likely as additional protection for the window opening). This vertical plate extended above the floor deck and was observable from the 3<sup>rd</sup> floor above as it extended into the upper sidelight depth (Photo 2).

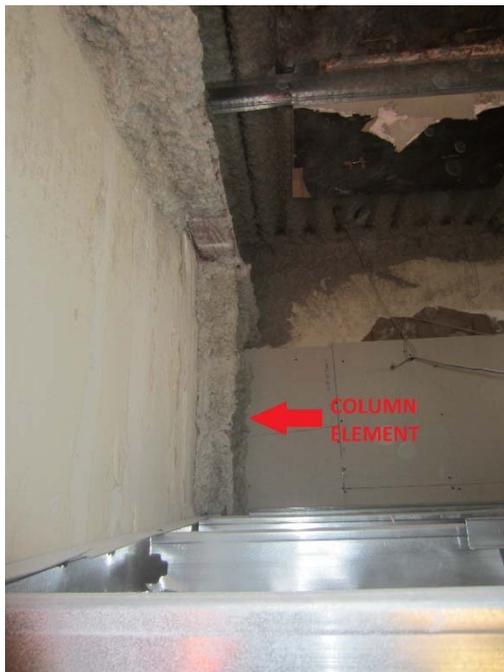
Photo 3 - Column Element Supporting Channel

3. The channel appeared to span along the west wall of the north wing and possibly bear on vertically-oriented column elements (possibly channel or wide flange shapes) also flush to the wall (Photo 3). Due to the presence of the fireproofing, observation of any attachment method to the walls was not possible.

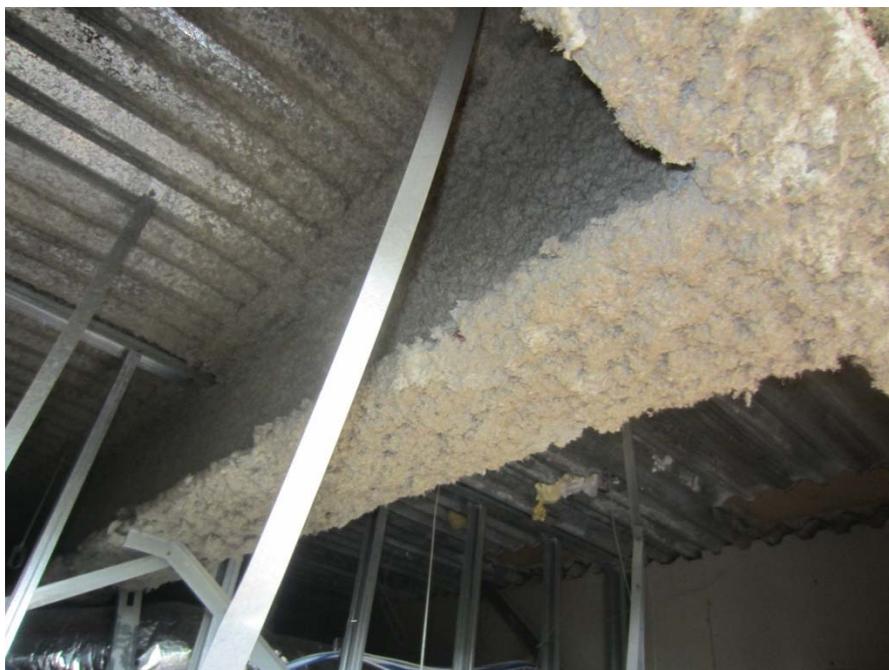
Photo 4 - Wide Flange Beam Framing Into Channel

4. Various wide-flange beams also framed into the side of the channel from the east (Photo 4). The majority were similarly fireproofed indicating that they were likely installed at the same time as the channel. These nominally 18 inch deep beams appeared to be bolted into the channel web. The wide flange beam located in front of window 264 was approximately 10 feet from the masonry wall to the north where the concrete-on-deck floor appeared to bear on a rolled angle attached to the wall, the top of the wall, or a combination of the two. Similar beam spacing was observed at window 266. However, additional uncoated framing was observed in the vicinity of window 266 (Photos 5 and 6). These beams appeared to be of a later installation (due to lack of fireproofing) and may be supporting filing and storage uses above.

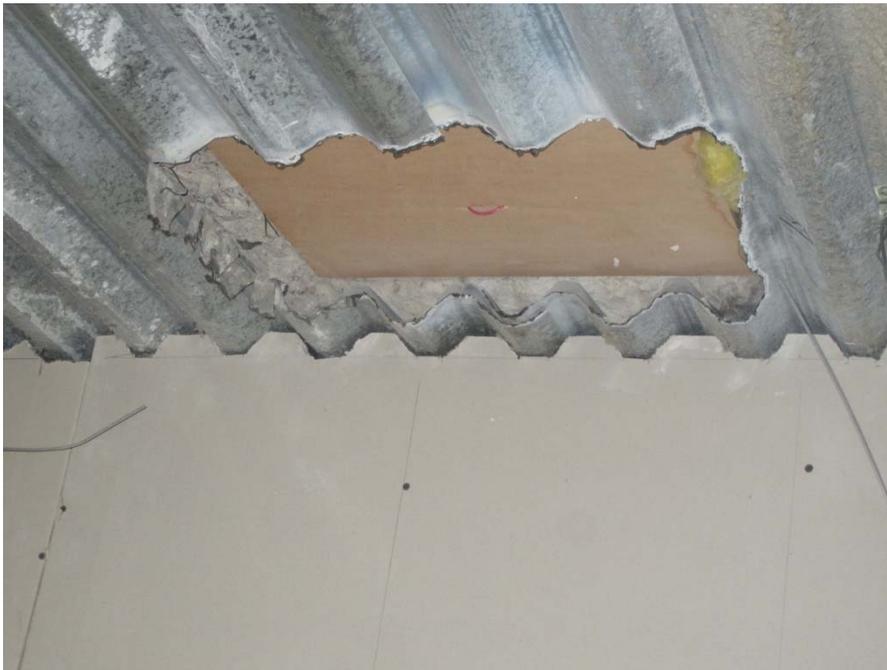
Photo 7 – Concrete on Corrugated Deck Portion of 3<sup>rd</sup> Floor

5. The beam and channel framing supports an approximately 3 inch concrete slab on a 2 inch deep metal deck floor with an approximate total thickness of between 5 inches and 5 1/2 inches (Photo 7).

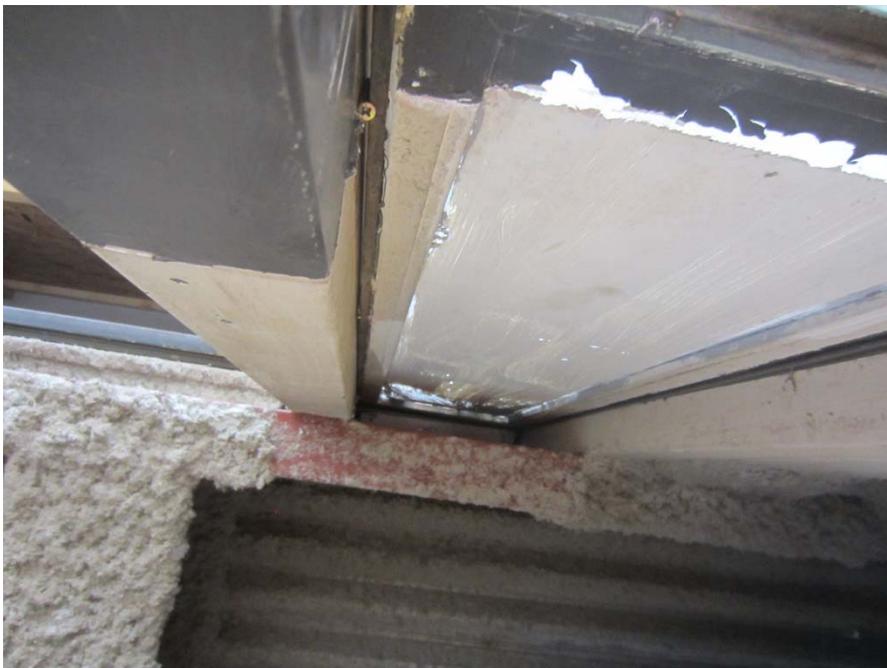
Photo 8 – Conflict at Top of Sidelight

6. Based on conversations with Heath Glenn, this channel was preventing the removal of the narrow, lower sidelights on each side of the aforementioned windows. The sidelight removal appeared to be contingent on removing a stay at the top of the window, tilting the sidelight frame into the interior, and then lifting it out of the larger window frame. The full 18 inch depth of the channel impaired the removal of the stay and prevents the tilting and lifting of the sidelight out of the frame (Photo 8).

7. After observing the framing and discussing the window conflict with Mr. Glenn, it was proposed that alternative window frame removal options be considered in lieu of attempting to modify the undocumented framing. It is our understanding that JE Dunn has begun to explore those options with the window designer and restoration subcontractor.
