OKLAHOMA STATE CAPITOL RESTORATION
Exterior Rehabilitation

OCTOBER 2016

15039DB MONTHLY CONSTRUCTION PROGRESS REPORT

Re: Oklahoma State Capitol Restoration – Exterior Rehabilitation
South Portico Barricade and Overhead Protection Review
TreanorHL Project #HP15.007.00B

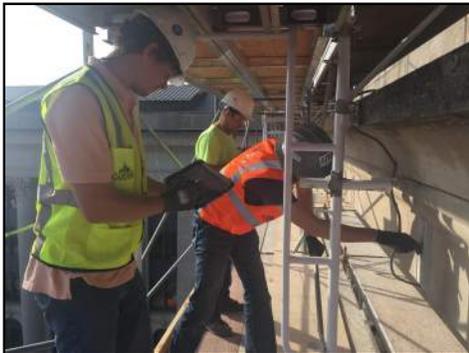
Tracking & assessing voids found in the stone joints following raking activities

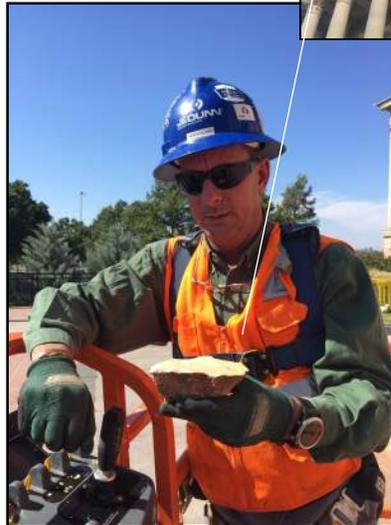
Heath Glenn (Superintendent) holds a large piece of stone that was found to be loose during the South Portico stone investigation.

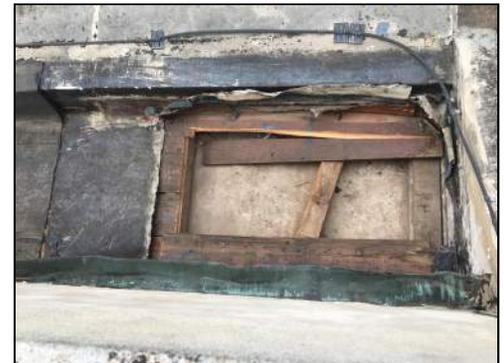
Built-in gutter abatement and demolition on the Alpha Elevation. The original Douglas-Fir wood framing was found to be in good condition.

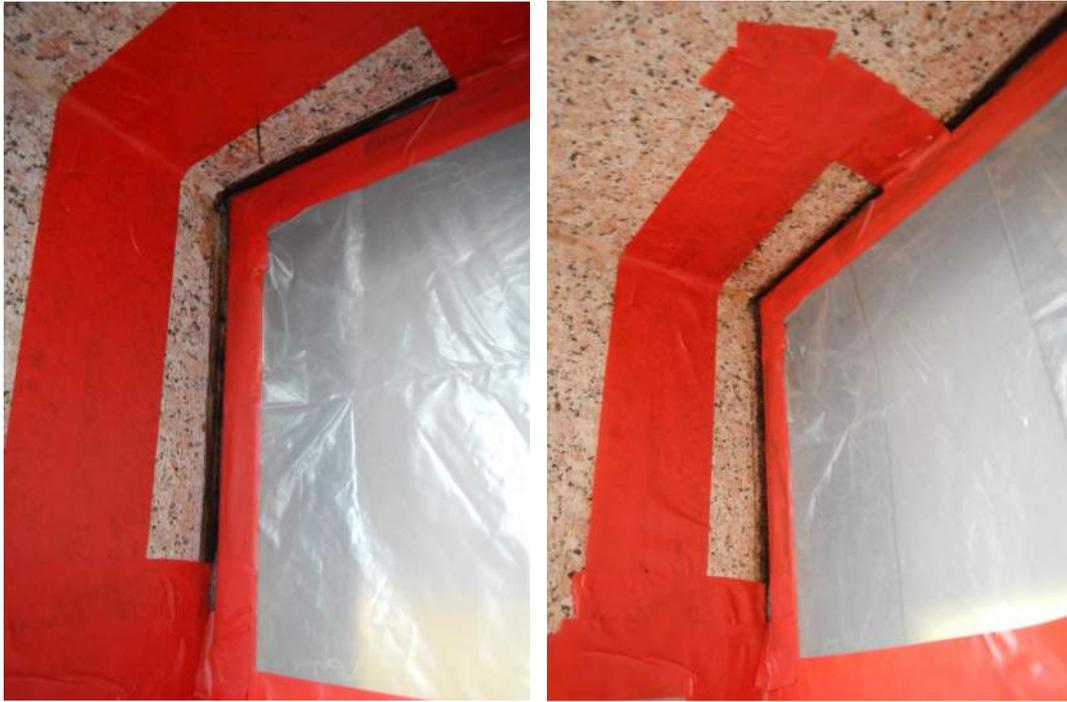
A206 – southernmost window bay – sealant residue removal trial – before and after second of two 10 minute applications of Prosoco Heavy Duty Paint Stripper and Afterwash

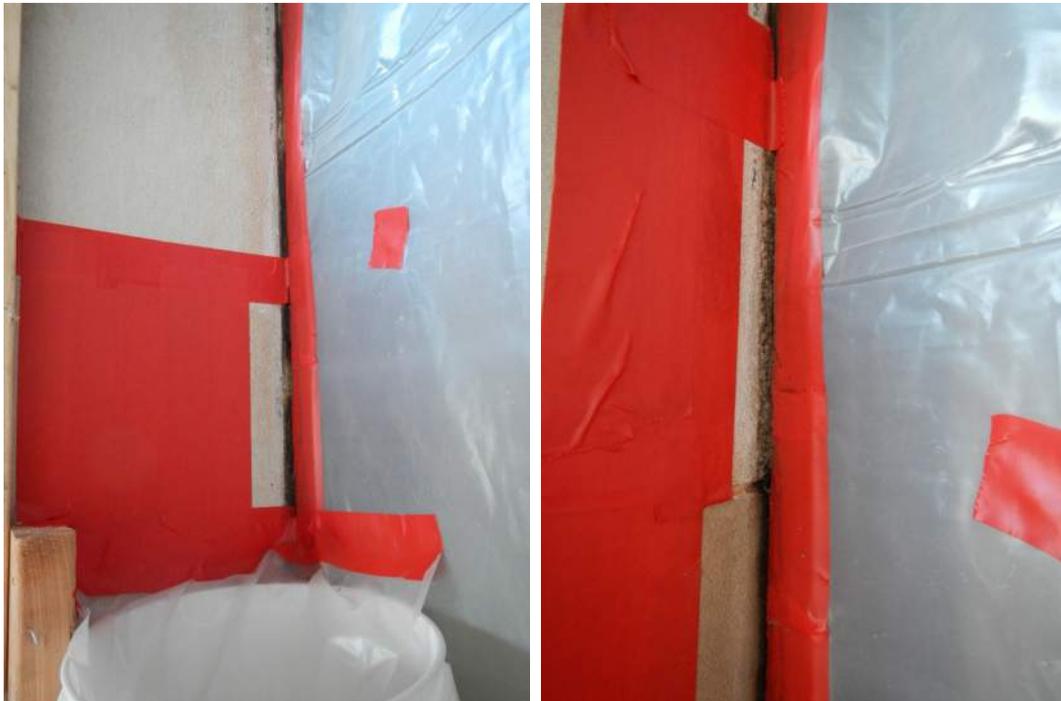
A206 – southernmost window bay – sealant residue removal trial – before trial one (left) and trial two (right) just above the first. Paint included in second trial. Prosoco Heavy Duty Paint Stripper.

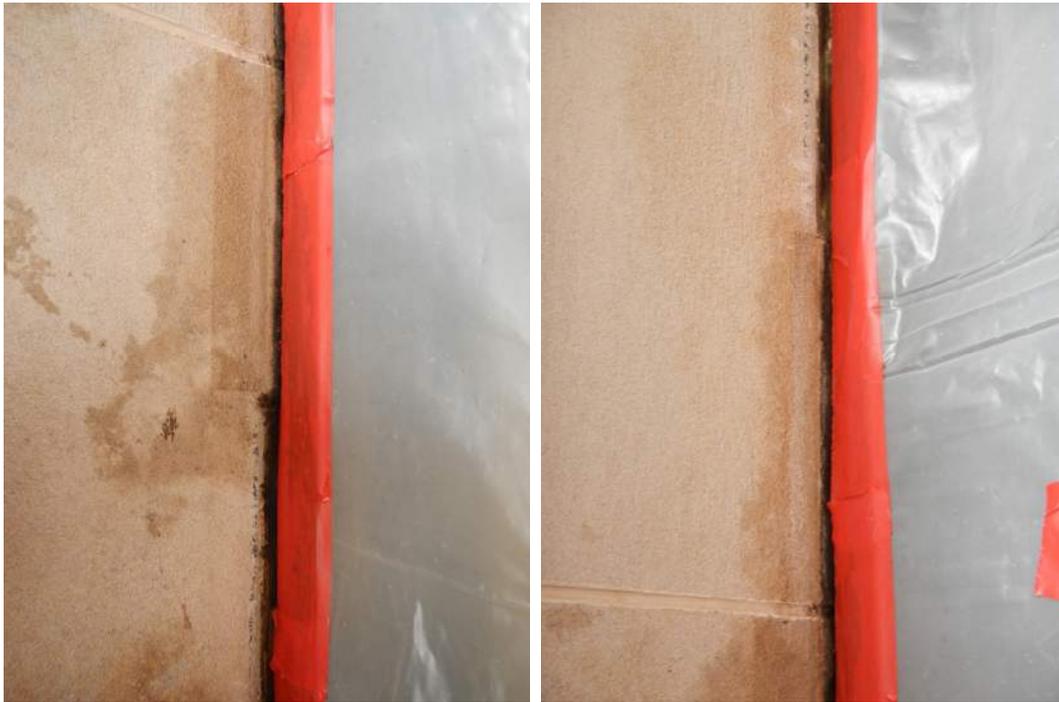
A206 – southernmost window bay – sealant residue removal trial – after photos. Left is first trial. Right is second trial after application of Afterwash and rinsing. Second trial more successful with longer dwell.

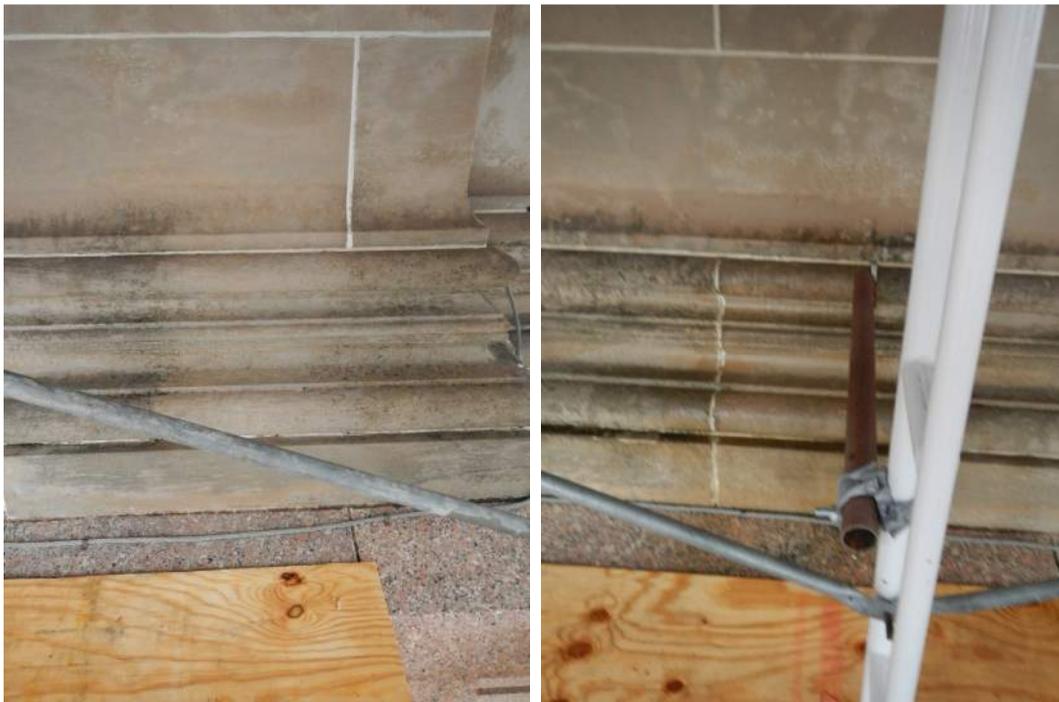
A208 – north end – biological spot treatment mockups, round 2. Initial mock ups did not produce the same results as trials had in the summer of 2015. On the left area in the center of the photo treated with ReKlaim for 15 min and then re-applied for 30 min. Prosoco 766 applied to the area in the center of the photo for 1 hr 15 min. Both areas still wet when photos were taken. While both produced results the results are not in keeping with trials performed last year. Another round of mockups is planned based on discussions with Prosoco.

Additional mock up for biological cleaning based on Prosoco recommendation for soaking prior to application of biological treatment. Location to be used is on A207, base of the first pilaster (around the corner from locations used on A208) because the soiling is similar. (Mark 1)

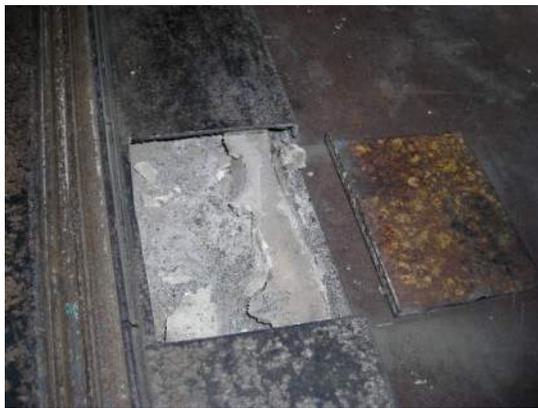
Location of window mark 349 pitting and investigation/cut-out verifying existing formed metal thickness is adequate at this location.

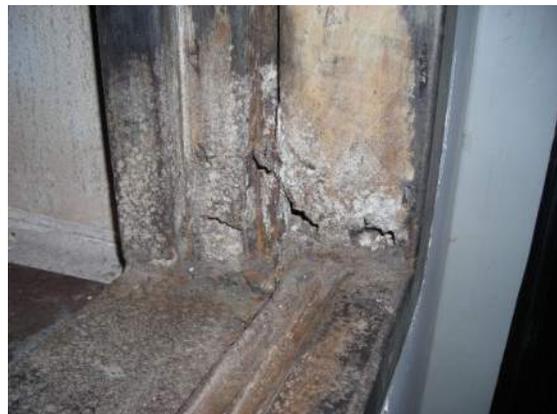
Location of window mark 349 north jamb deterioration. Note mortar in sash pocket behind frame.

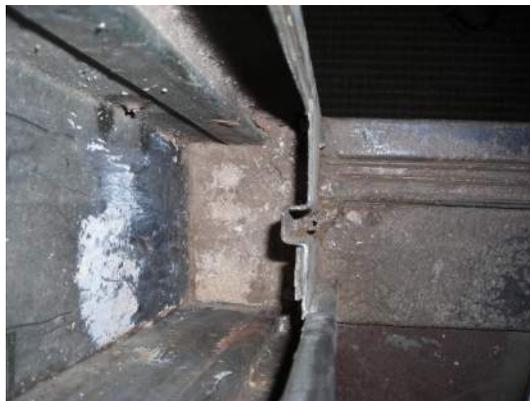
Location of window mark 349 north jamb deterioration. Note mortar in sash pocket below ,behind frame.

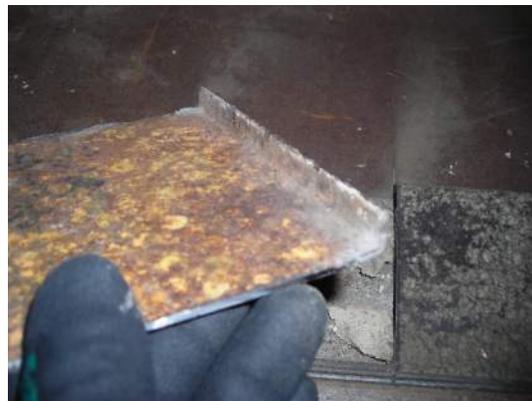
Location of window mark 349 with deteriorated sill front drip edge. Final finishing technique needs to be determined.

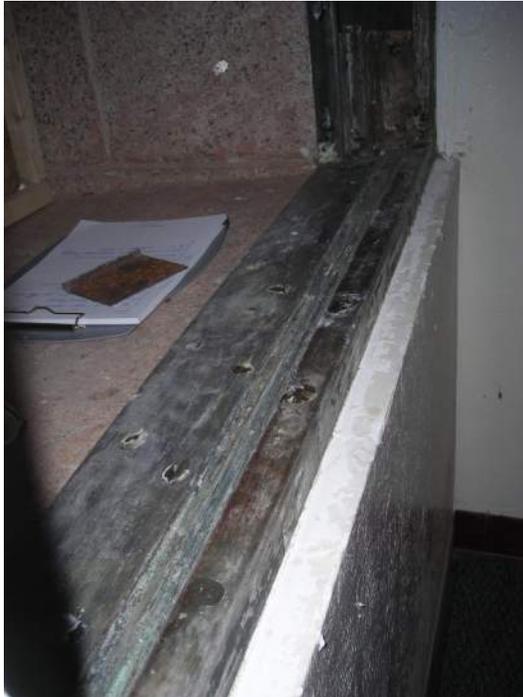
Location of window mark 159 with spaced testing locations within "area of potential concealed deterioration"

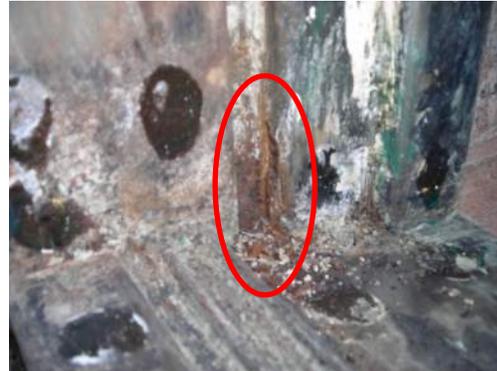
Location on window mark 159 with deterioration behind unremoved paint/corrosion/etc. in parting stop reveal.

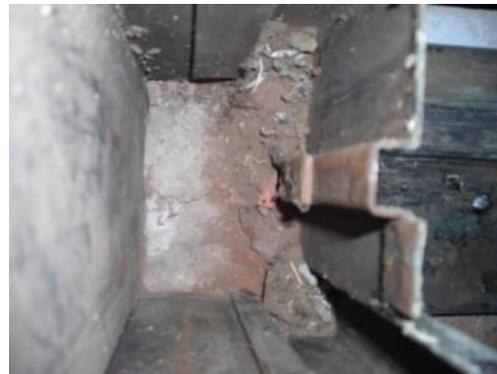
Location on window mark 159 behind stop reveal deterioration. Note that back side of frame appears continuous with mortar level below line of metal.

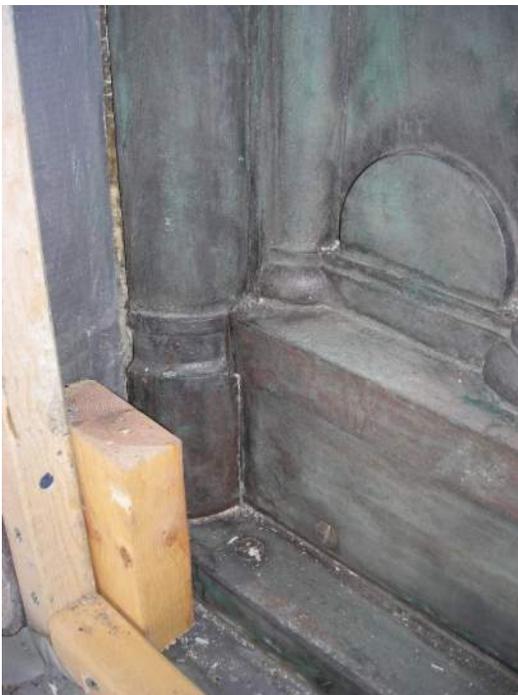
Final abatement of finishes on cast iron. Note seams that need additional removal. Confirmation of how to treat these reveals/joint needs to be determined especially at horizontal joint that will come in contact with perimeter masonry/window sealant joint.

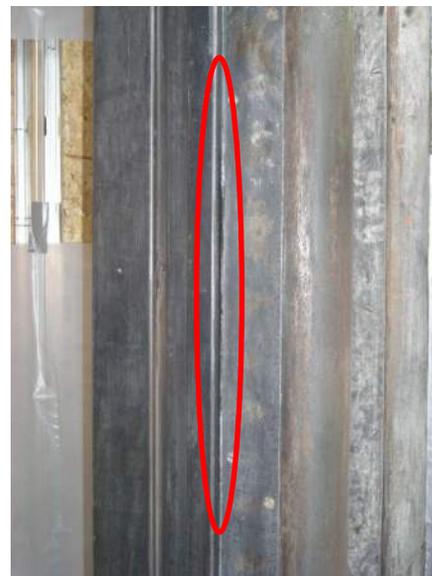
Note joint that is filled with what appears to be a bituminous material. Extent of removal of this material shall be verified with paint finish manufacturer.

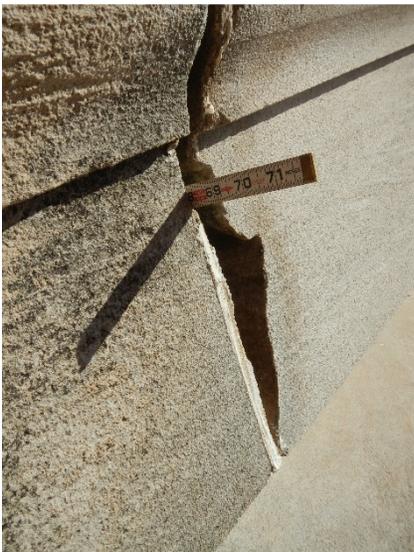
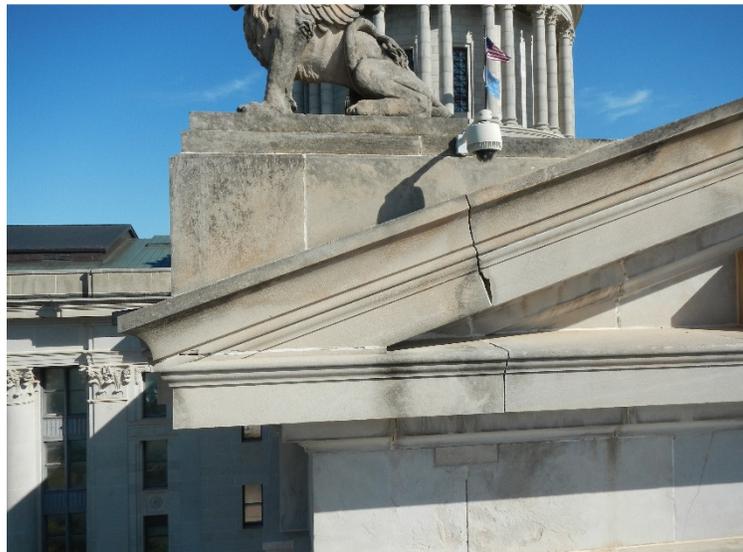
1. Mortar joints (horizontal and vertical) are severely deteriorated.
 - a. Mortar exhibits cracks both along and perpendicular to the joint.
 - b. Loose mortar could be removed by hand and in some areas is deteriorated enough to be raked with a tape measure.
 - c. Mortar depths after removal were generally shallow (less than 1 inch), which is consistent with other areas observed throughout the building’s façade.
 - d. Mortar is missing in locations; some joints have been washed out and are open more than 60-inches deep into the wall.
 - e. Sky facing joints in the rake and around the plinths under the griffins are deteriorated.

Open mortar joint, west rake – detail on the left, elevation view on the right (joint under the camera).

We recommend that the access restrictions and overhead protection remain until the entire façade can be evaluated at close range and repairs made. Improvements to the current arrangement could be implemented:

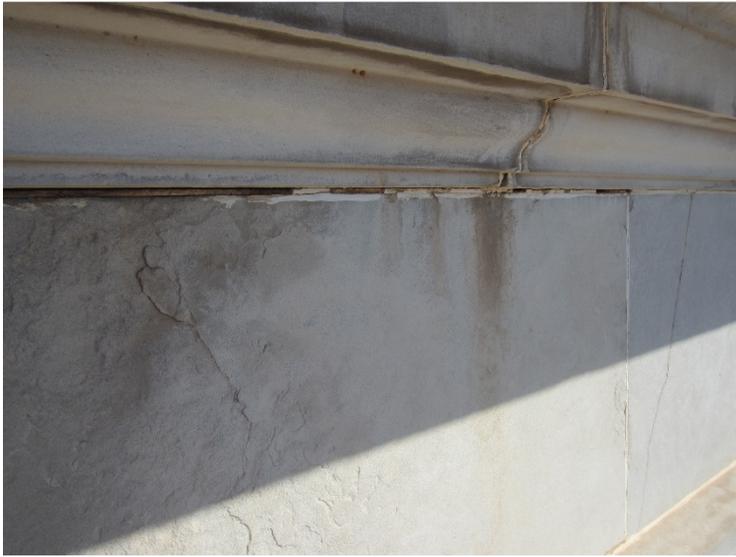
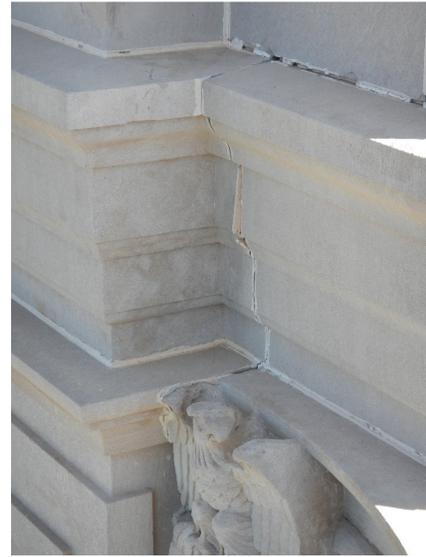
Left Photo: Bed joint above the frieze course, west side of the portico. Mortar removed from this joint with an extended tape measure. Right Photo: Dislodged mortar caused by water infiltration at the west portico return in the architrave course; area was out of reach of the lift.

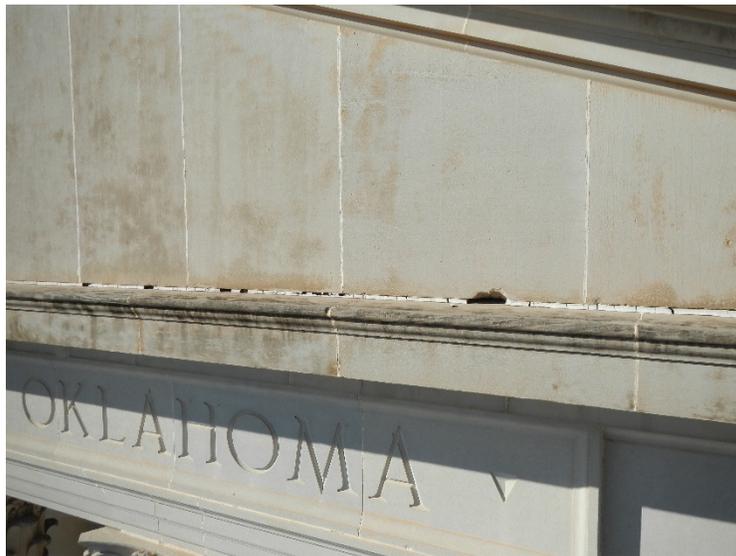
Missing mortar and stone at bed joint of tympanum allowing water into the fascia course below.

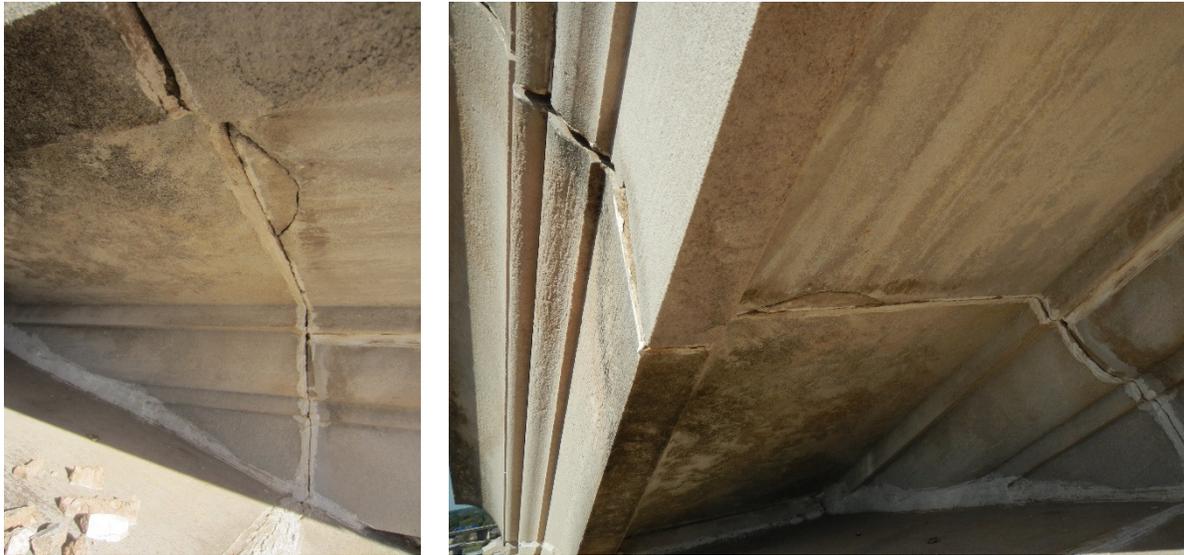
2. Stone unit deterioration was noted in several locations.
 - a. Small spalls were removed from the portico.
 - b. Loose stone was noted on the underside of the raking fascia, but could not be removed with hand tools. Piece appears to be wedged.
 - c. Exfoliation that could result in falling material was observed on the frieze and on the underside of the horizontal and raking fascia courses.
 - d. Cracks that could indicate incipient spalls at typical anchor locations were observed in the frieze at four locations. The restricted lift access prevented up-close observations.
 - e. Potentially loose material was noted on the west return, but was not accessible from the lift.
 - f. Spalls have occurred at corroded anchors on the west return of the portico. The anchors and surrounding stone are subject to further weathering and potential loss.

Loose fragment on underside of west rake, below open mortar joint.

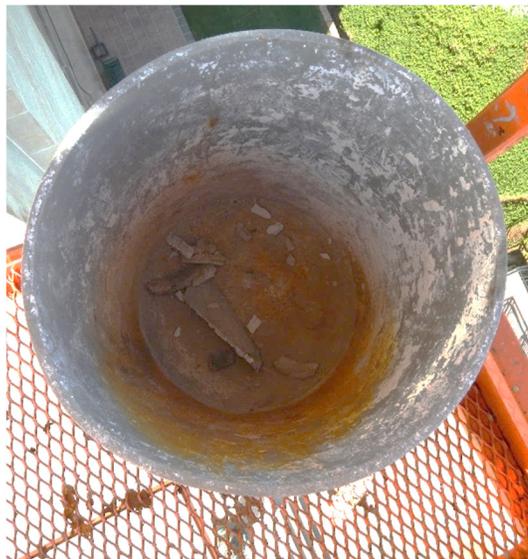
Stone spall and loose mortar removed from east rake end.

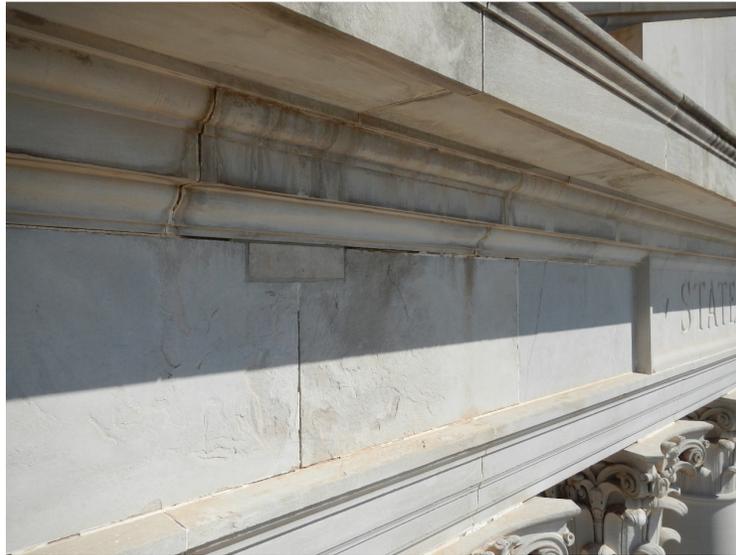
- 3. Evidence of water migration through the assembly was observed.
 - a. The underside of both the raking and horizontal fascia courses exhibit mineral staining consistent with water moving through open joints and saturating stone. Exfoliation of the stone frequently accompanies this condition.

Staining and exfoliation on the bottom of the fascia, face of the corbel and face of the frieze caused by water migrating through open mortar joints. Repair at frieze is from WJE investigation at a deteriorated ferrous anchor.

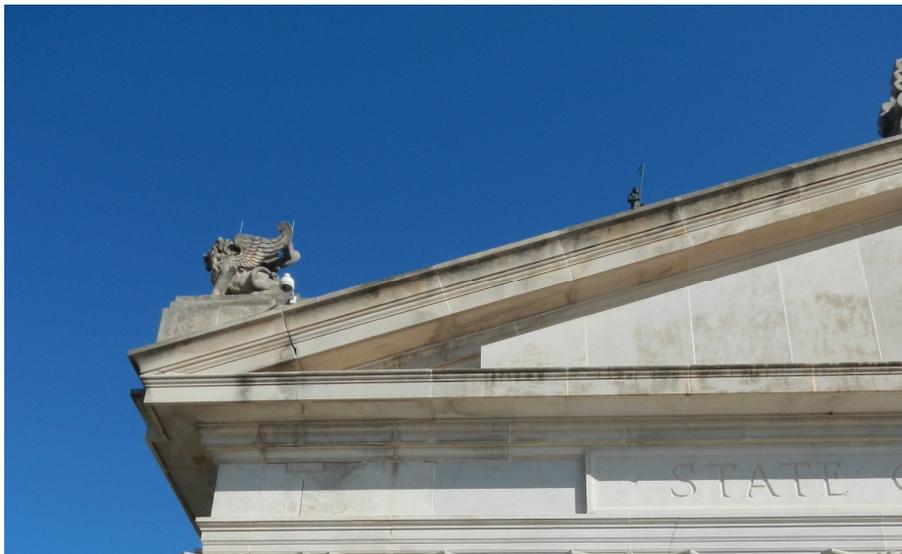
Staining on the bottom of the fascia and raking fascia resulting from water migration through open mortar joints. Severity increases closer to the corners. West corner shown.

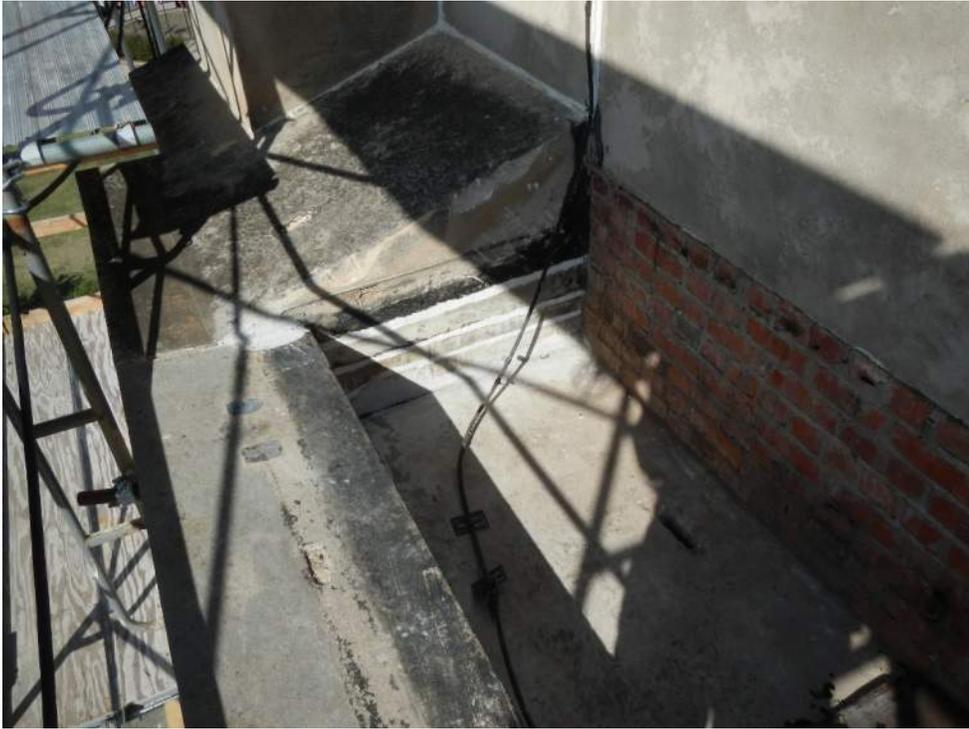
A206 – gutter end wall condition reviewed and discussed on site – mock up required.

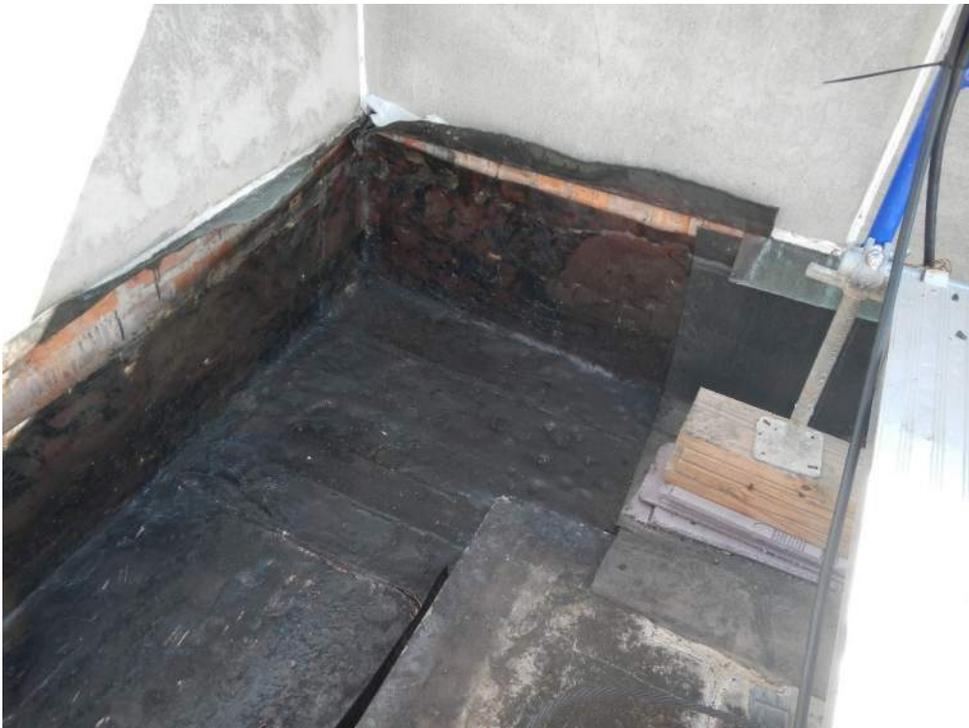
Interior corner where A206 and A205 meet – expansion joint to be placed as permanent construction; end of existing gutter to remain until A205 is worked will be temporary and make use of expansion cap cover to terminate.

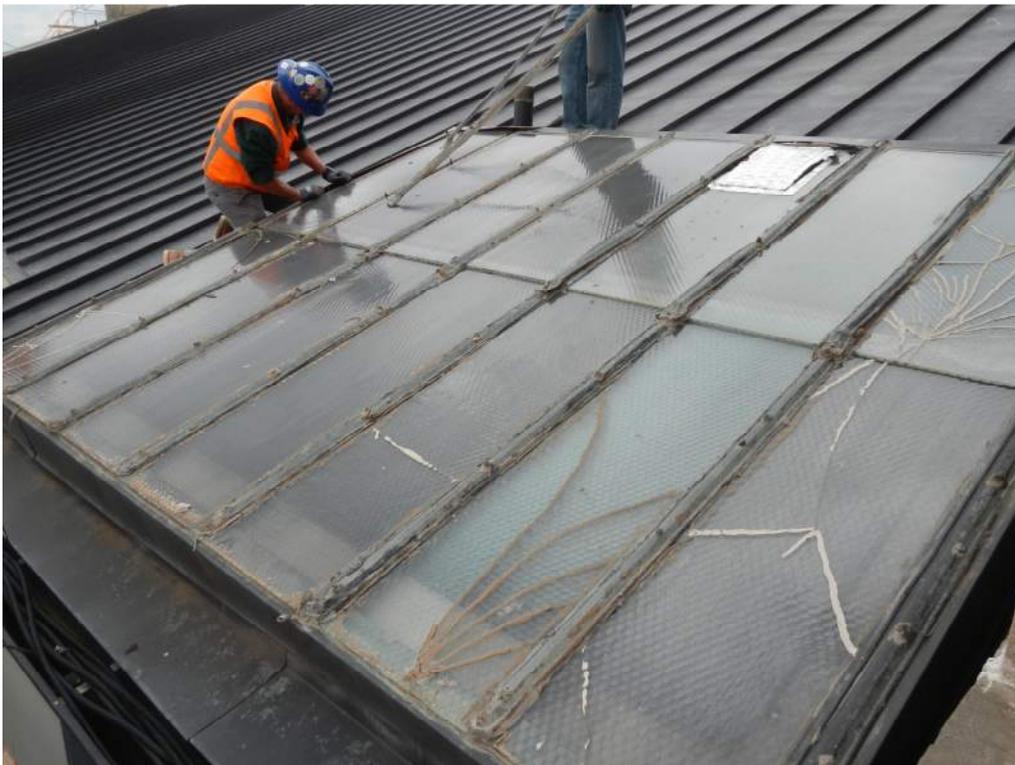
Reinstallation of glazing that provided access to shaft under north skylight (west slope). Interior of both east and west was observed – sides appear to be mirrors of one another.

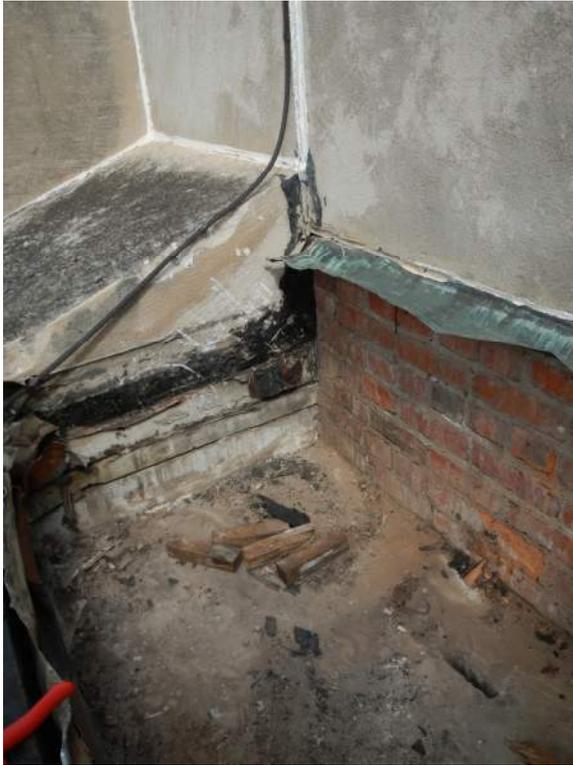
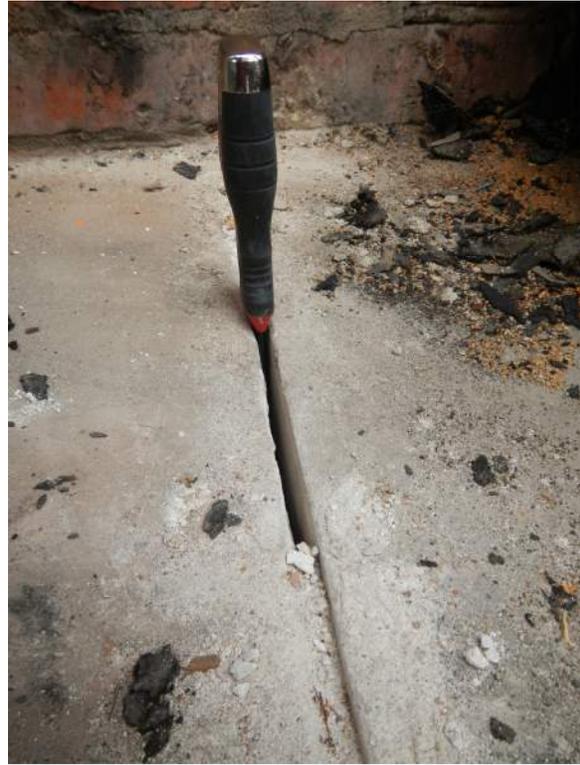
Gutter substrate conditions revealed by removal of membrane, copper and sub-framing. Brick and mortar are largely in good condition. Open mortar joints were found in stone work. Additional reglets were revealed that secured copper on both the end and side wall (back of corona). Removal at north end of A206.

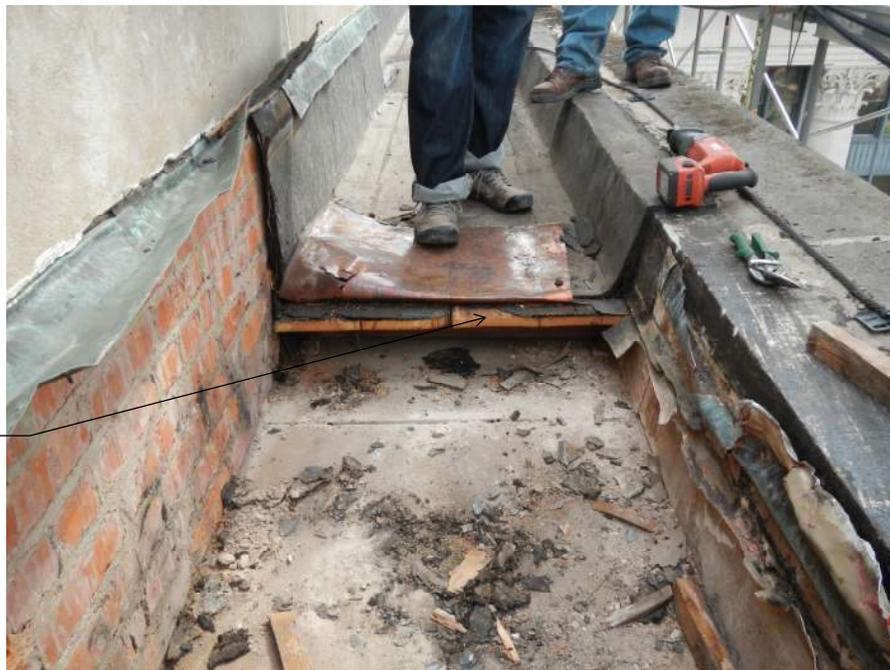
Looking south in gutter along A206.

original Douglas-Fir wood framing was found to be in good condition.
