September 2015

Oklahoma Capitol Restoration Project

Interior Rehabilitation
Monthly Progress Report

Monthly Project Status Report**Date:** September 29, 2015**Project:** 15151DB – Capitol Interior Restoration

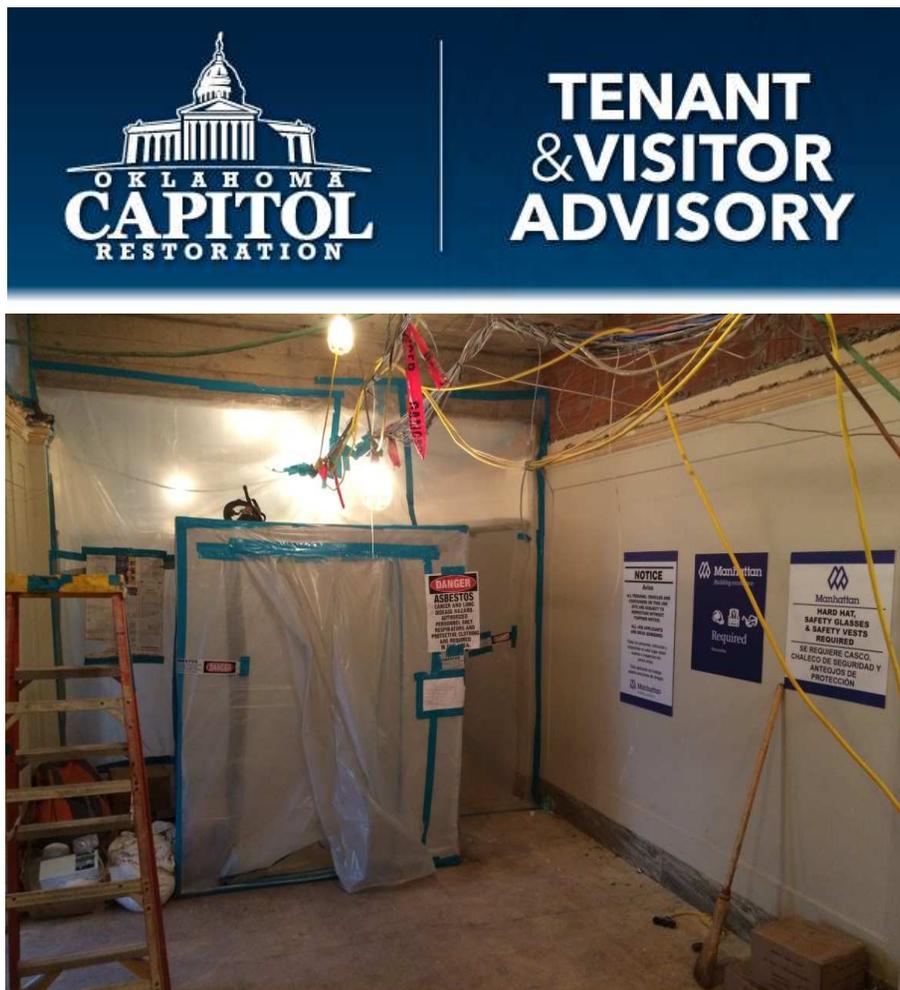
Image above: Area of full containment undergoing asbestos abatement. Abatement of Asbestos Containing Materials (ACM) was completed this month for the prerequisite areas under construction.

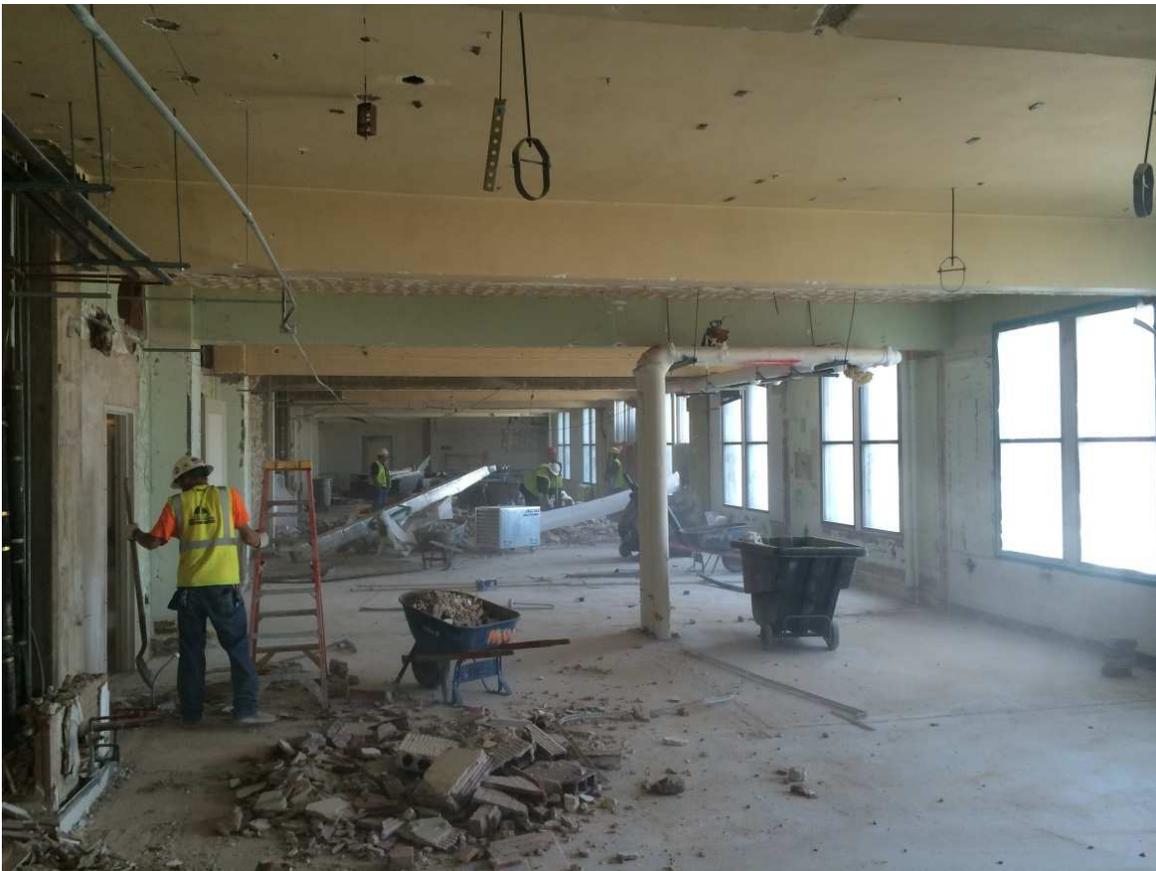
Image above: Demolition in progress which completed in early September.

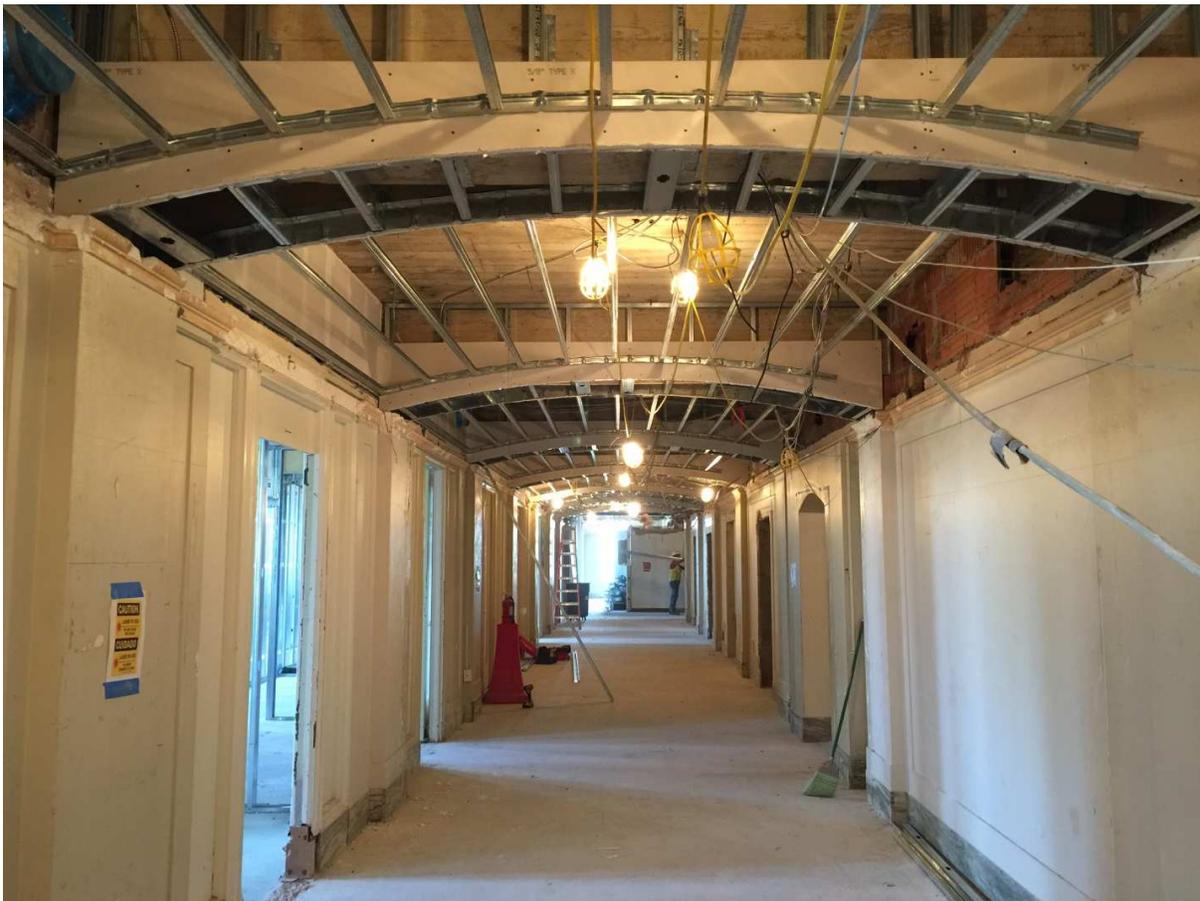
Image above: Historic barrel vault ceilings in corridors have been recreated. Many of the original framing components of the historic plaster ceilings were discovered abandoned above false lids. However, much of the original plaster had been removed decades ago. Modern wall systems, including acoustic barriers and fire/smoke rated partitions are now in place.

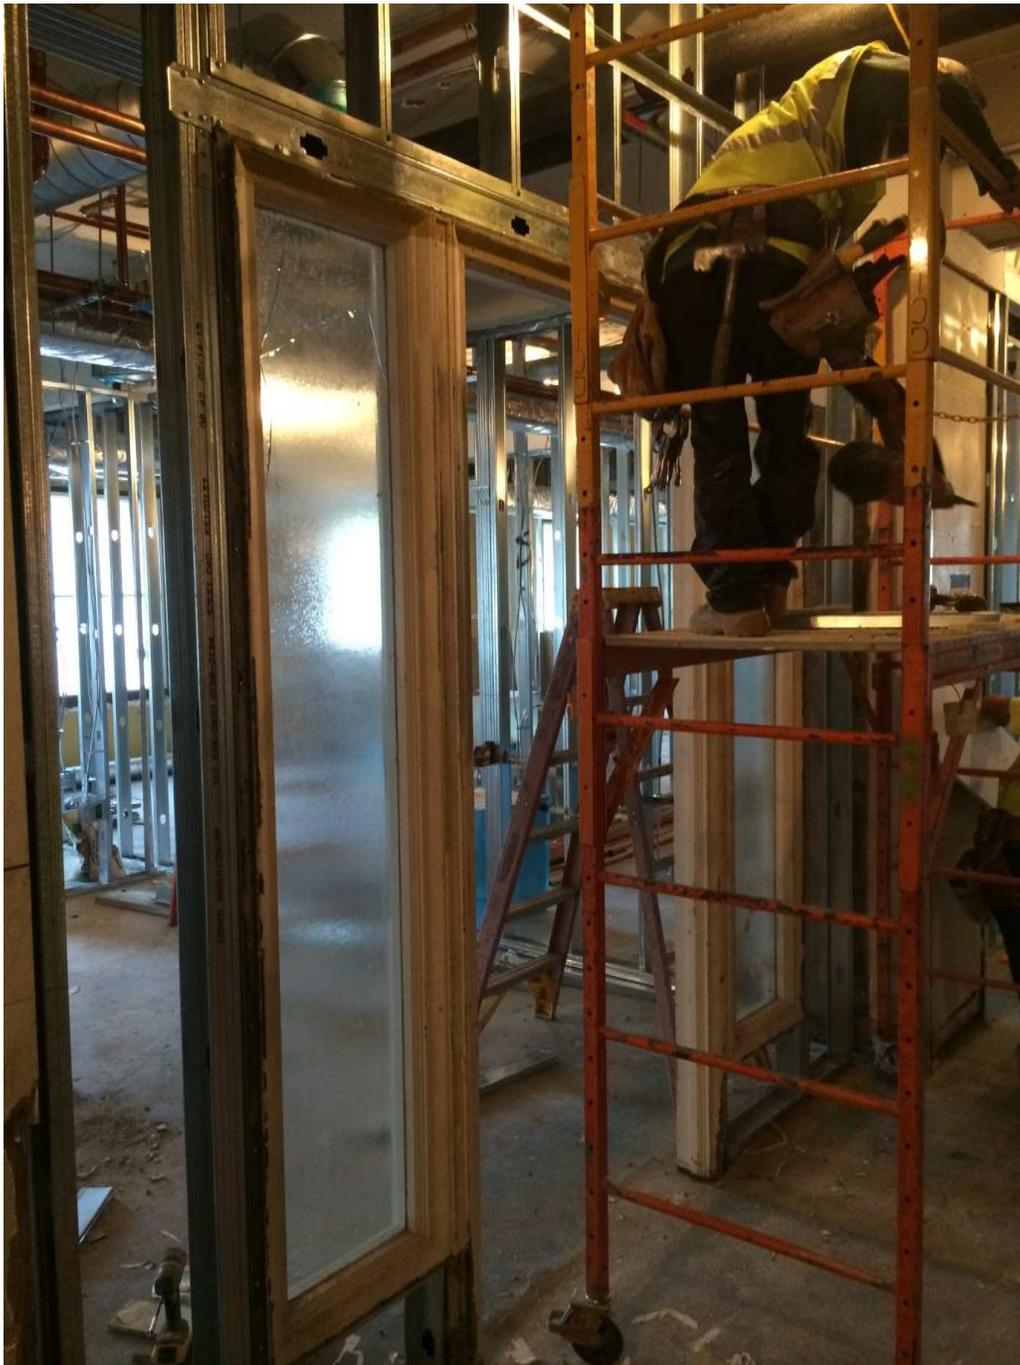
Image above: Original metal frames for doors and sidelights, were carefully removed and salvaged during demolition activities. These original frames are being reused where possible and will be restored to their original grandeur throughout the interior restoration.

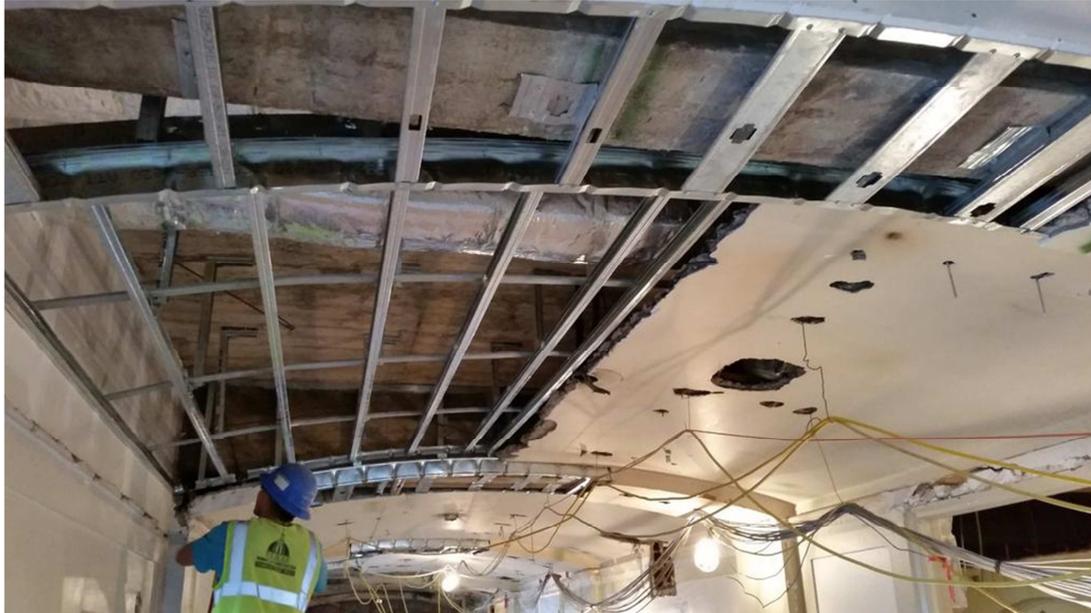
Image above: New meets old. Portions of the original plaster ceilings remained hidden until demolition activities were completed. New plaster ceilings will be installed for a seamless finished appearance to recreate the original ceiling profiles and historic trim details.

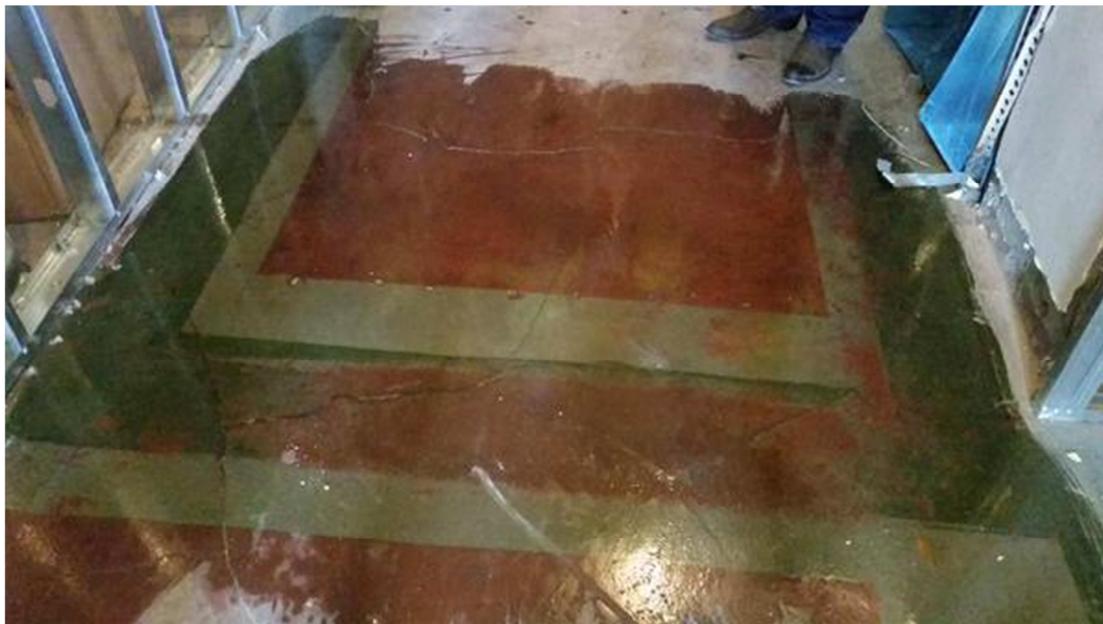
Image above: Following abatement of hazardous materials contained within layers of flooring added over the decades, original flooring details were discovered. Floors were integrally stained red with topical painted borders applied as shown above. These significant design features will be respectfully represented through future finish selections as Capitol Standards are being developed.

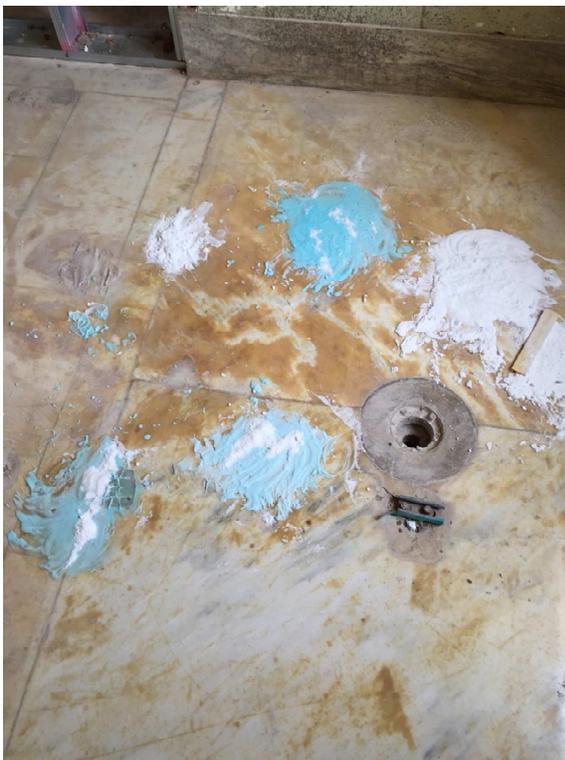
Image left: Poultice testing in progress. Poultice testing is meant to extract stains from within the original marble caused by adhesives used with topical floor finishes previously applied over the marble. Our team did not anticipate reduction in the staining from poultice testing which is being confirmed. Thus far, poultice testing has not produced reduction in staining on original marble surfaces.

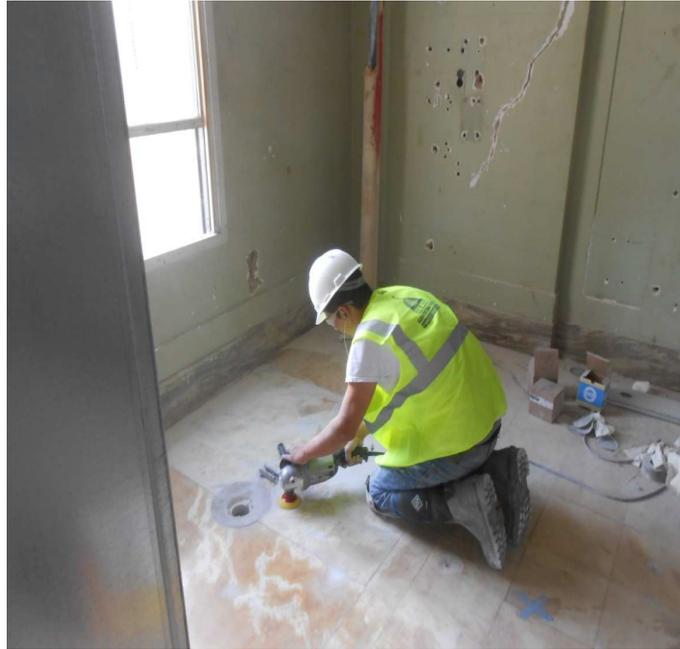
Image above: Refinishing process using a horsehair grinding brush to remove a century of dirt and grime as well as polish the original marble. This area on the third floor is being used for testing and restoration treatments.

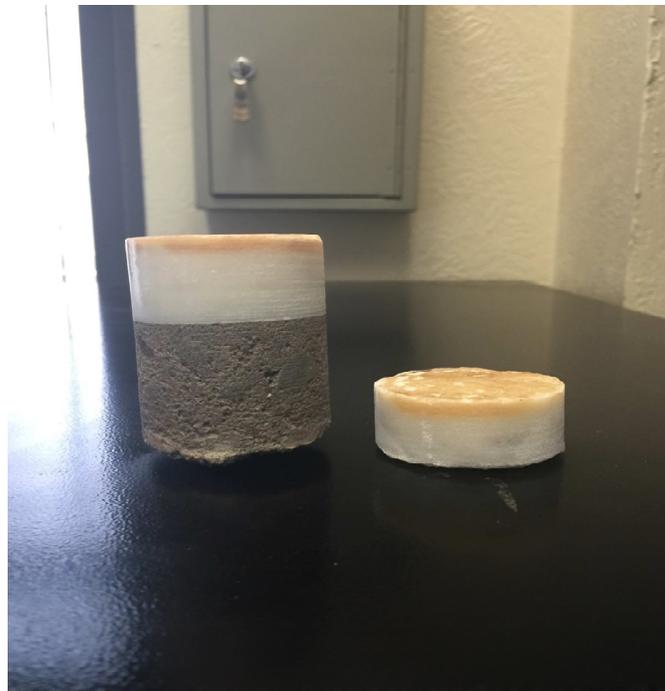
Image above: Core samples have been taken of the marble for laboratory analysis. Staining is shown penetrating the existing marble surface by $\frac{1}{4}$ " – $\frac{3}{8}$ "

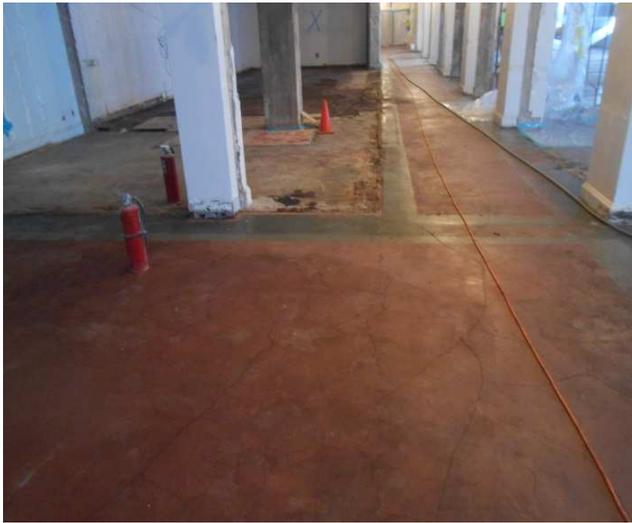
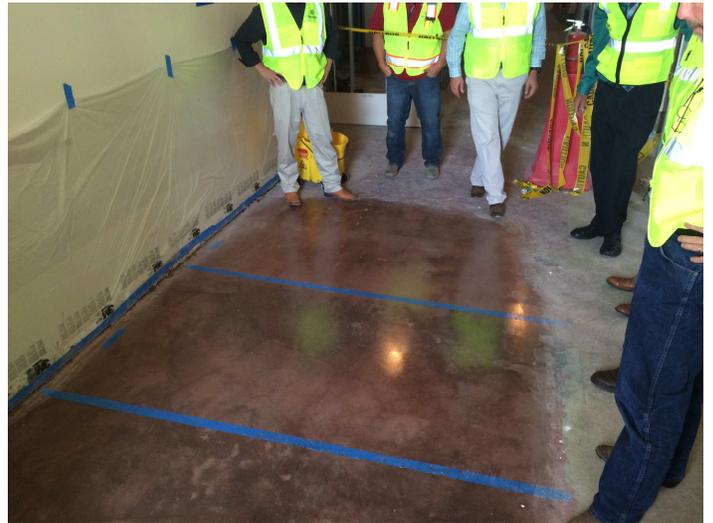
Images: (Left) Original floors exposed on the first floor showing integral red stained concrete and painted borders. (Right) A mock-up was provided showing different types of polishing and sanding methods for team evaluations to continue with future finish selections and development of Capitol standards. (Below) Collage of images taken through September 2015.

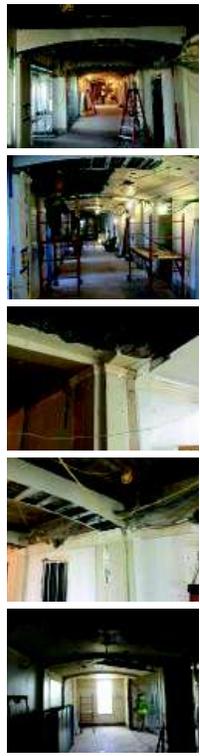
ITEM	REMARKS	DISCUSSION	PHOTO
2-001-002	Ceiling General progress

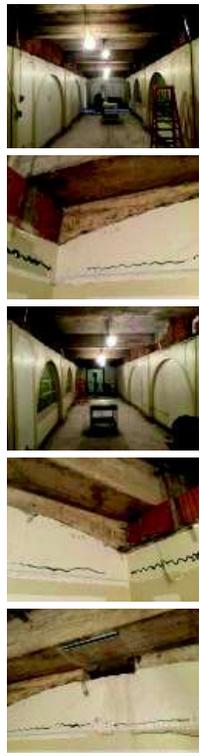
ITEM	REMARKS	DISCUSSION	PHOTO
2-001-006	Ceiling Ceiling removed

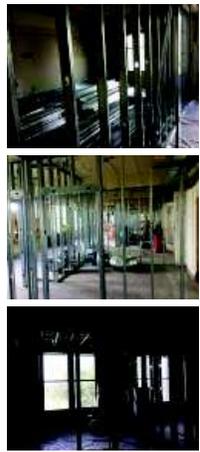
ITEM	REMARKS	DISCUSSION	PHOTO
2-001-008	Wall framing General progress

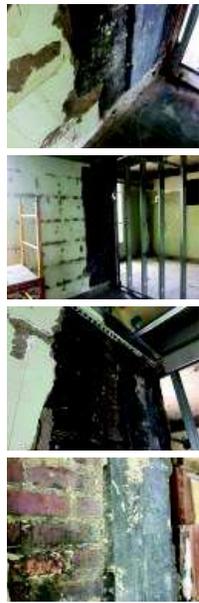
ITEM	REMARKS	DISCUSSION	PHOTO
2-001-011	Plaster Exterior wall

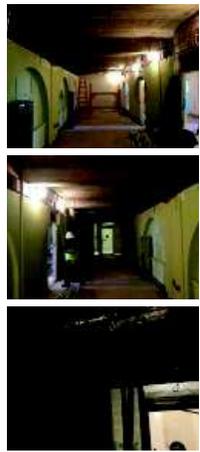
ITEM	REMARKS	DISCUSSION	PHOTO
2-001-013	Ceiling Ceiling removed

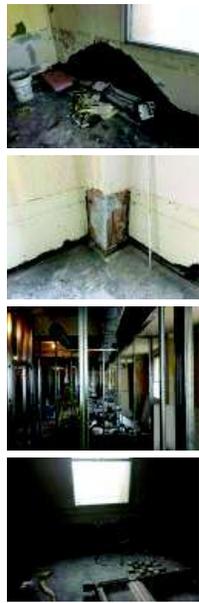
ITEM	REMARKS	DISCUSSION	PHOTO
3-001-002	Plaster Exterior wall 2" thick!
